VEHICLE OVERHAUL INSTRUCTION

PB/VI2133

PORTERBROOK MARK 3 LOCO HAULED COACHING STOCK AND HST TRAILER VEHICLES

Issue: 5

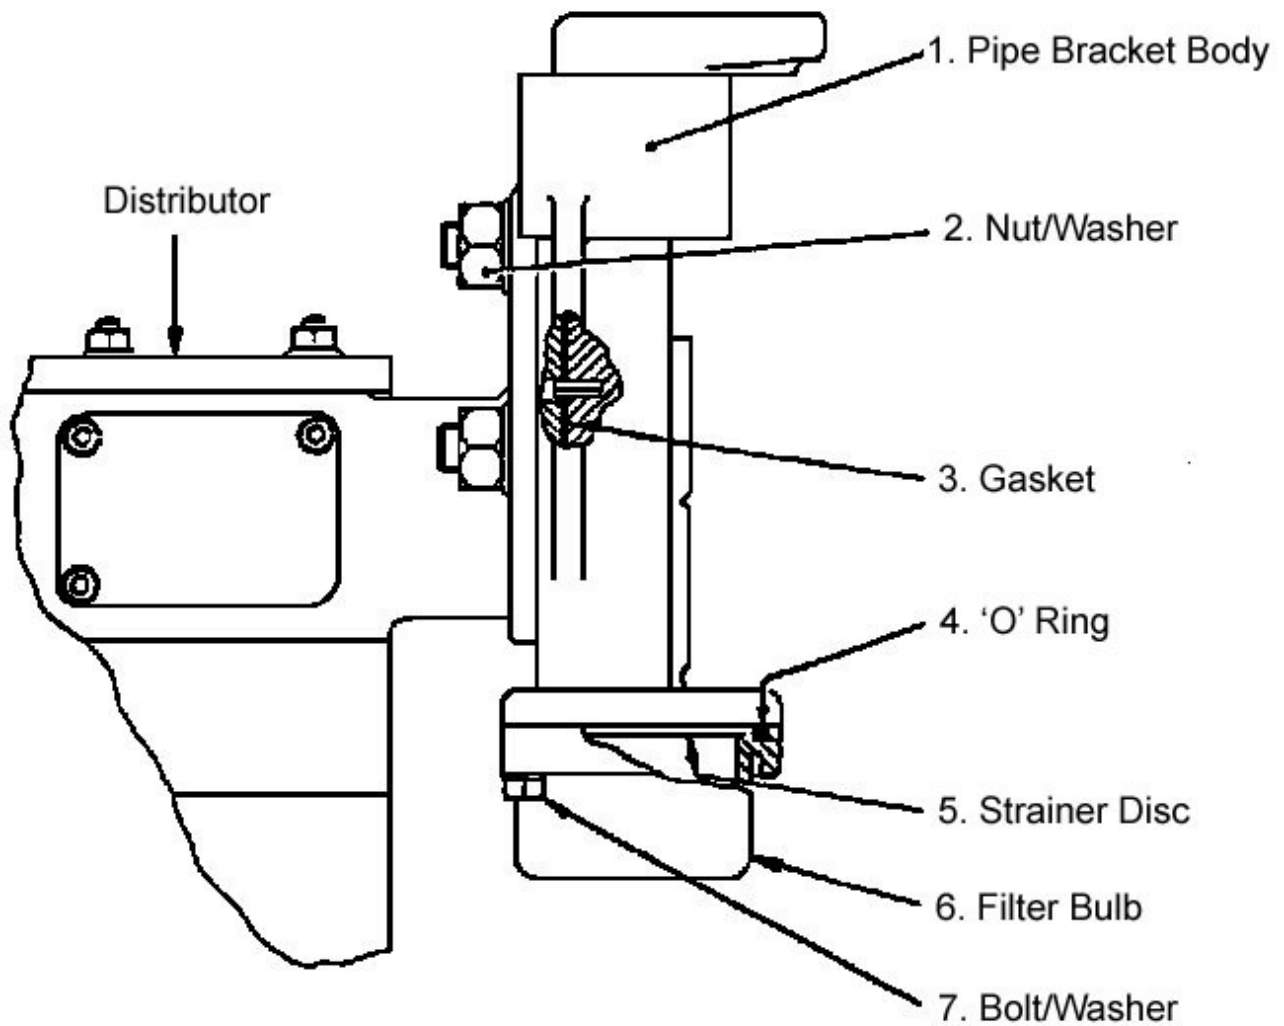
**Figure 1: Distributor Pipe Bracket
Westinghouse Part No. J75108/498**

3. Change a defective pipe bracket.

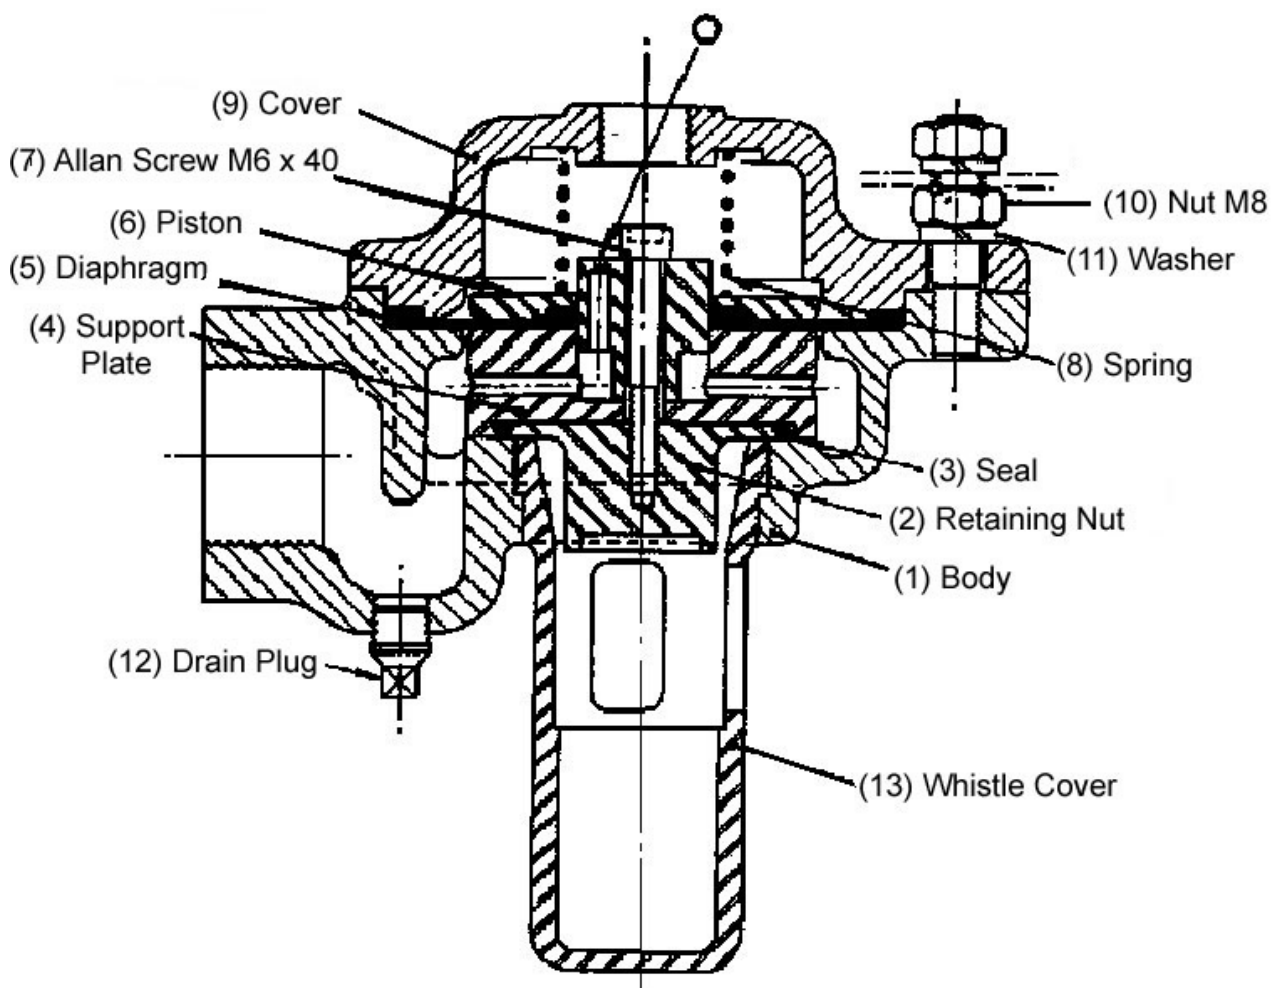
Figure 1: Davies and Metcalfe Passenger Communication Valve (BR Cat No. 070/070572)

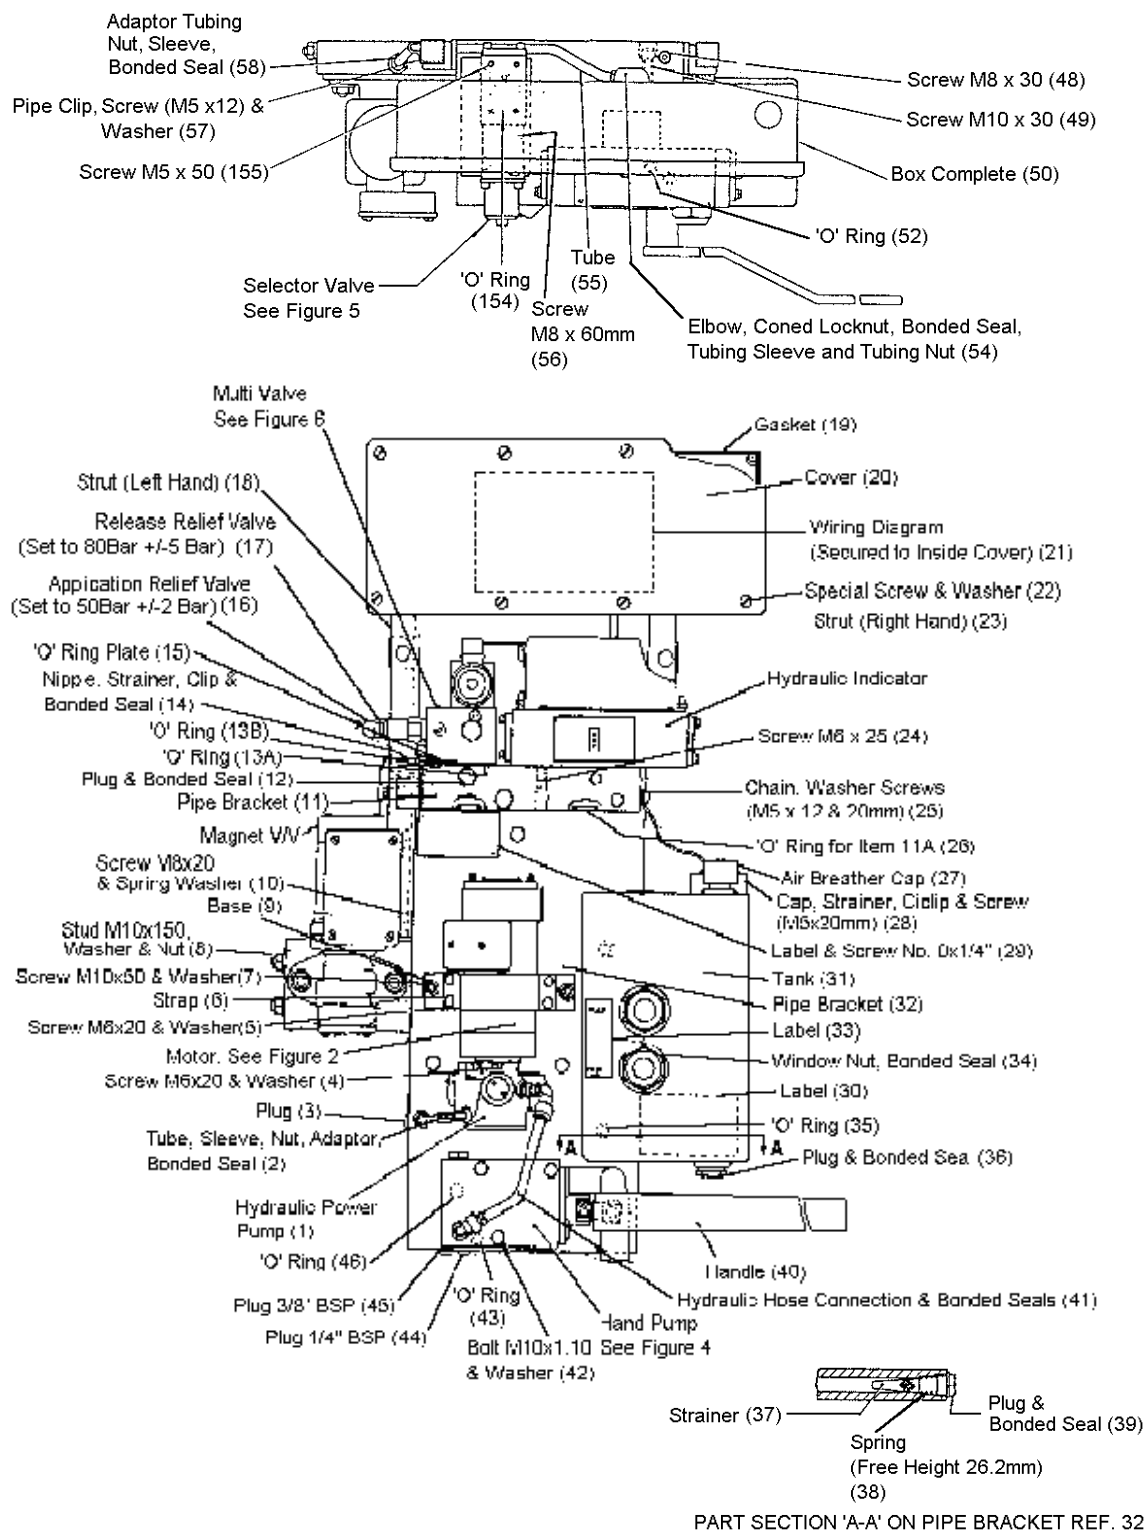
BH 0119

Figure 1: Hydraulic Parking Brake Control Unit - General Arrangement

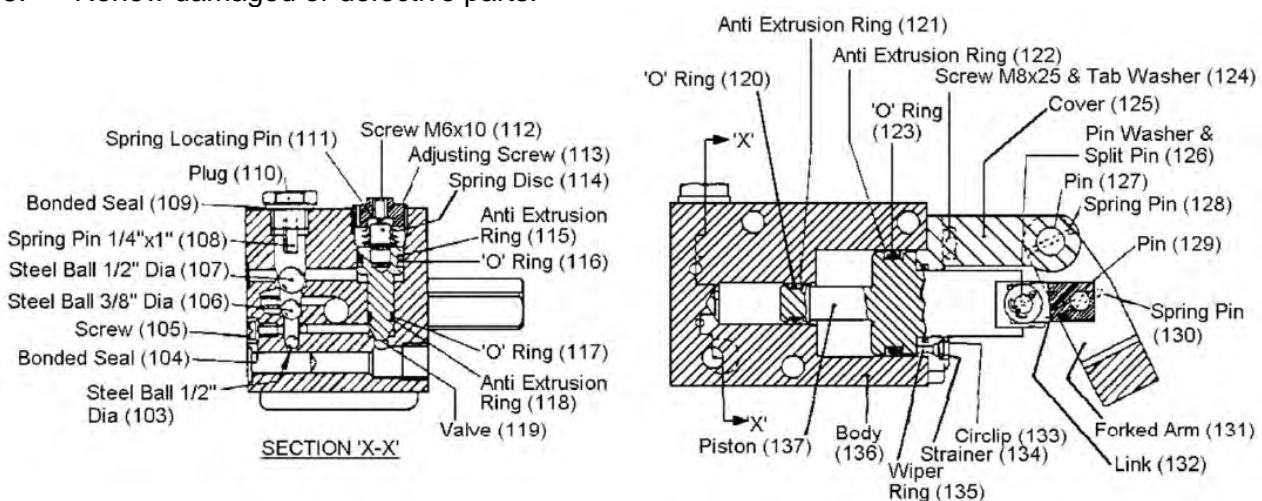
Figure 2: Hand Pump

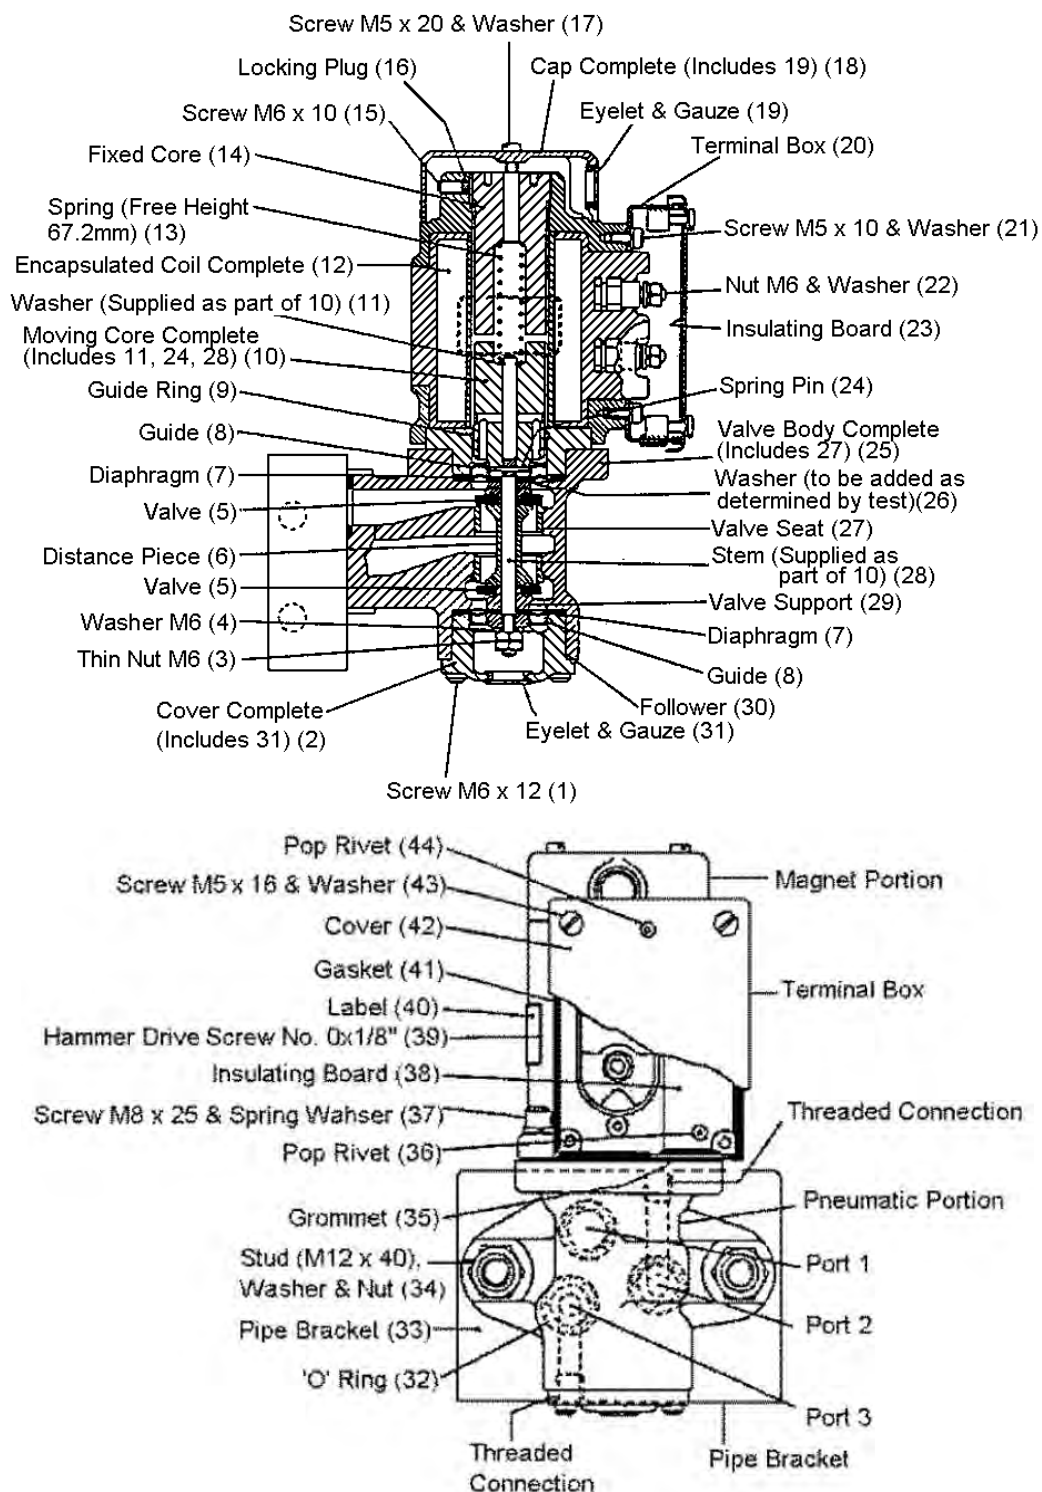
BH 0119

Figure 6: Direct Acting Magnet Valve

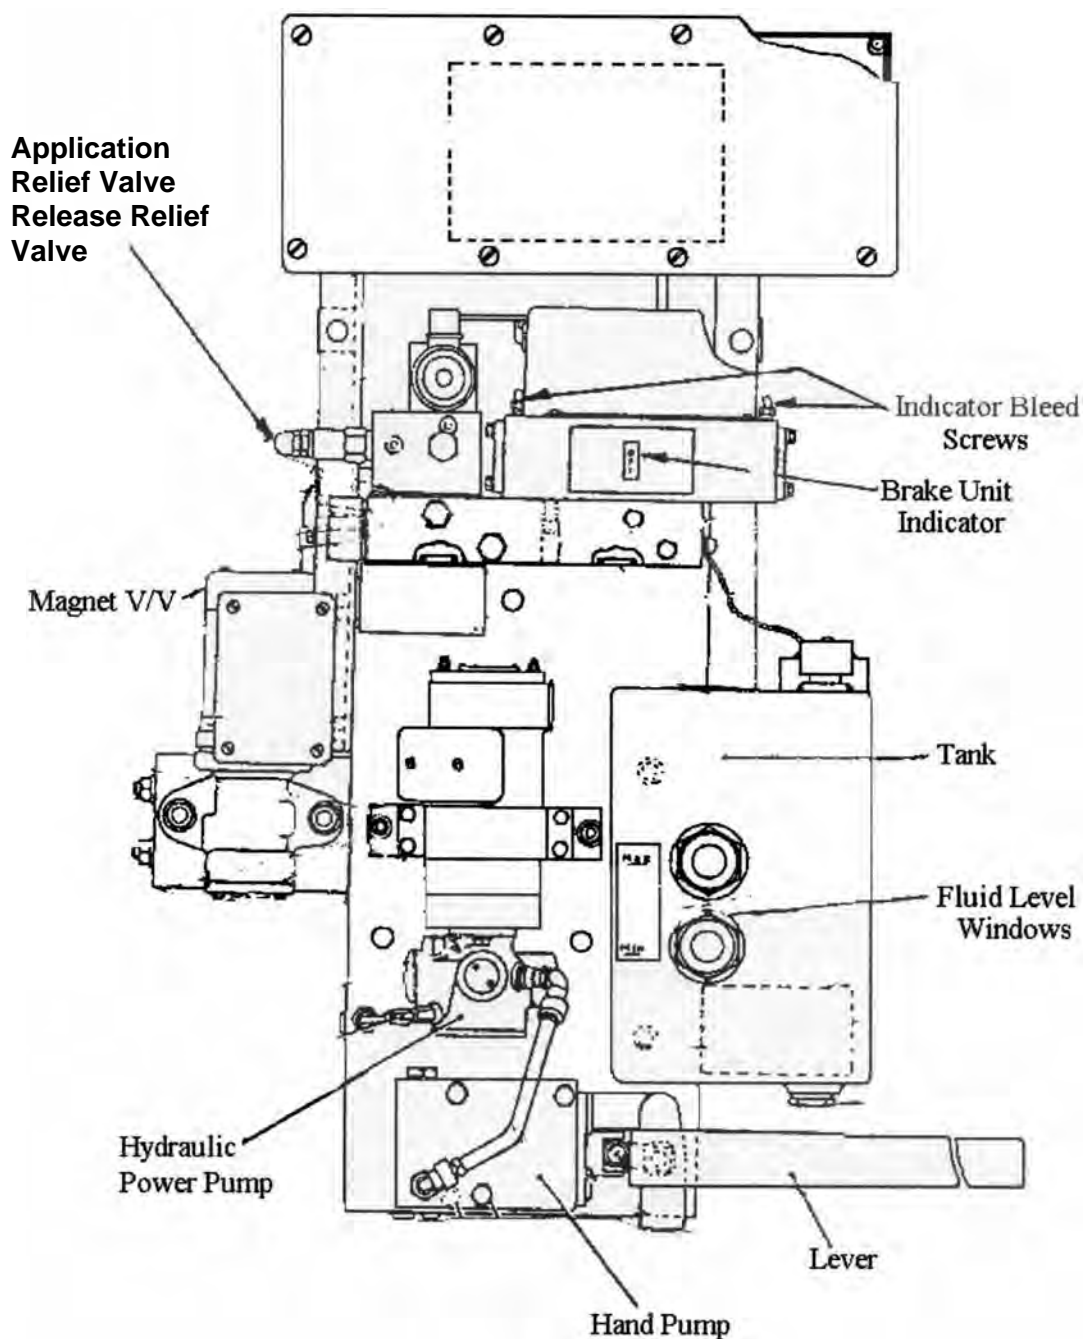
BH 0305

Figure 1: Arrangement of Hydraulic Parking Brake Control Unit

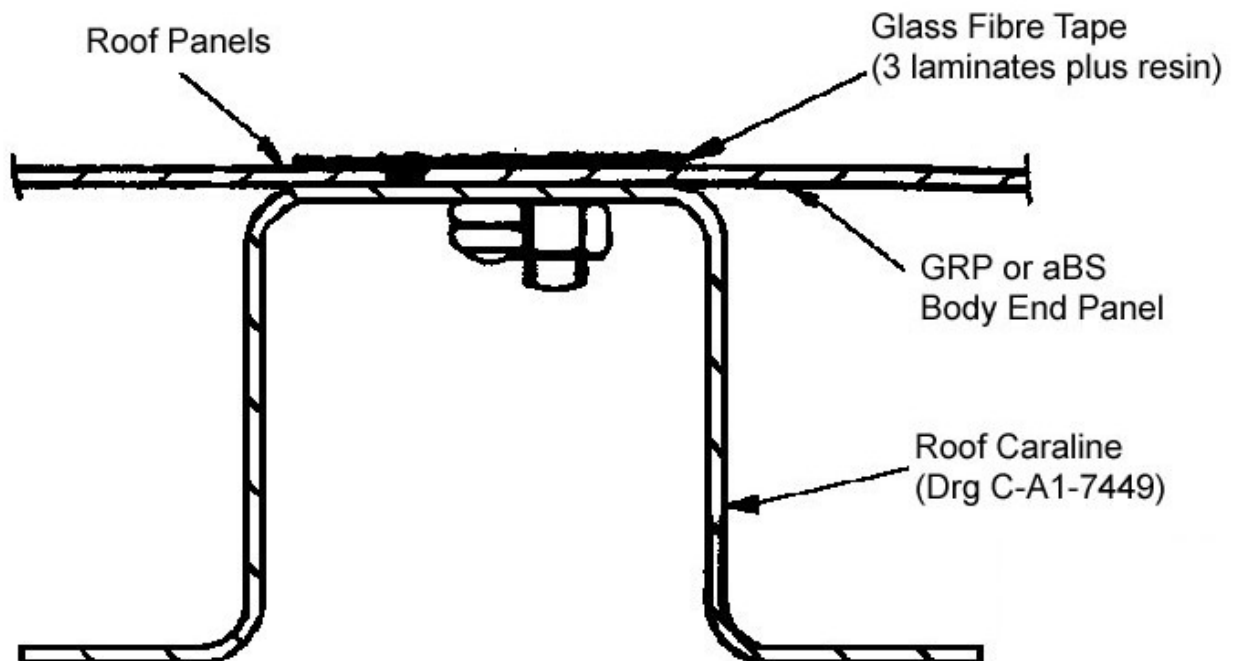
Figure 1: Joint Sealing

NOTE: Repair corroded or damaged body structure in accordance with Job No. CA 6001 arising work.

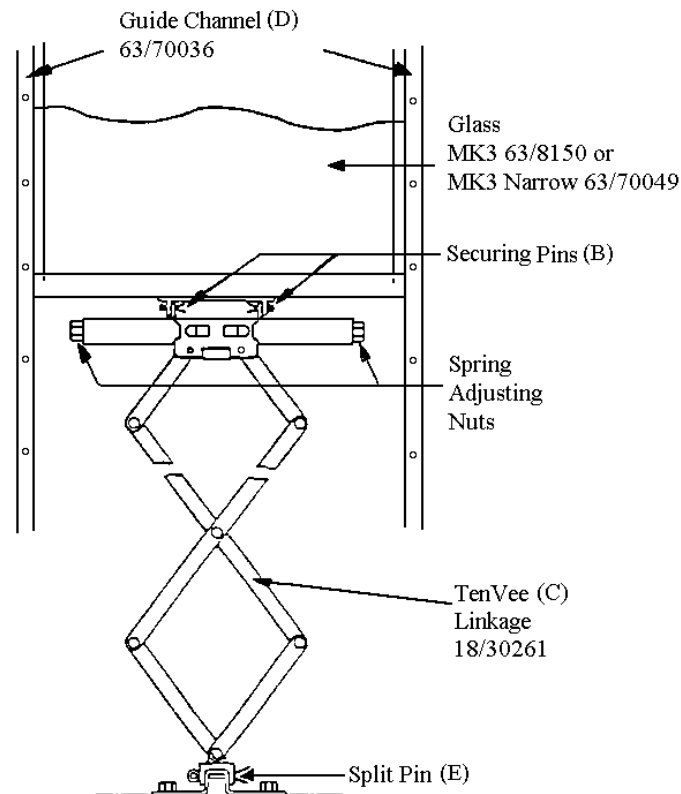
CM 6615

Figure 1: Balance Mechanism

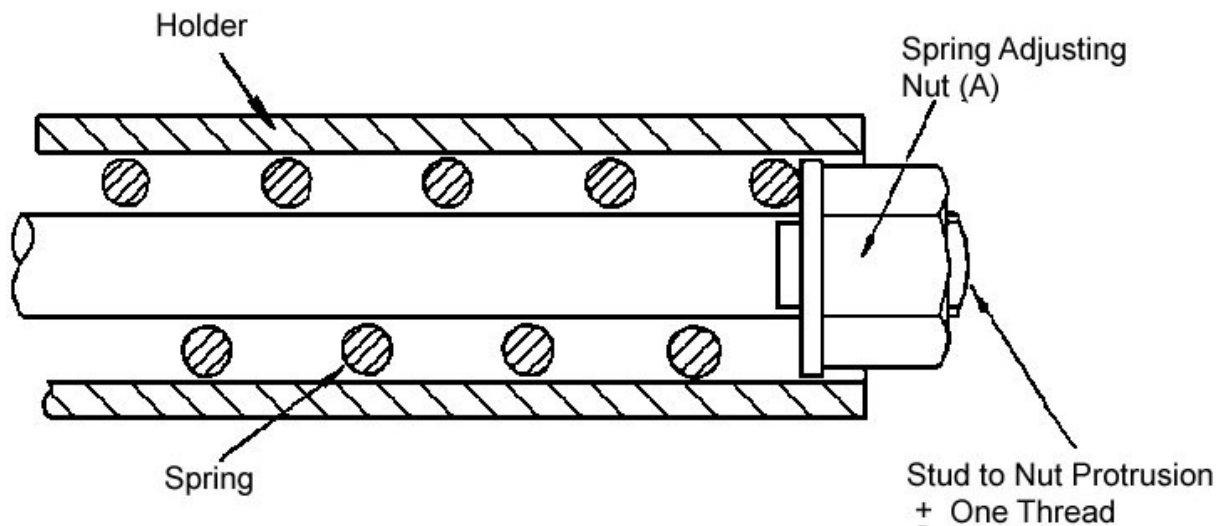
Correct the balance mechanism by altering the spring compression, turning both nuts (see Figure 2 item A) by equal amounts in small increments. Turn anti-clockwise to correct for overbalance and clockwise to correct an underbalanced condition.

Figure 2: Section of Spring Holder

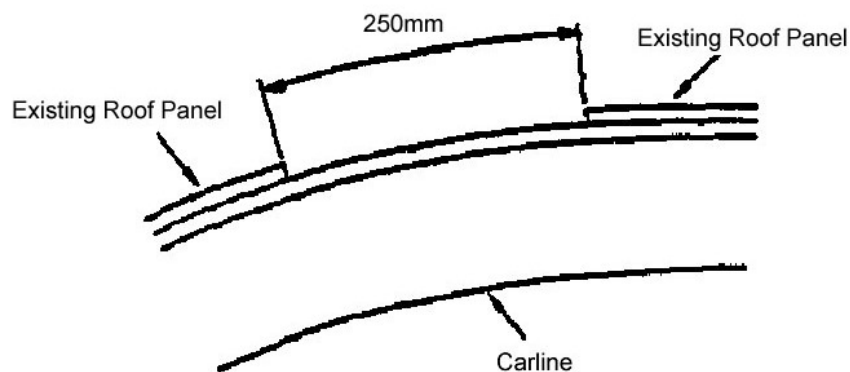
1. Heavy Corrosion/Holes - Width exposing less than 250mm of carline (see Figure 1).

Figure 1: Repairs Width Exposing 250mm of Carline

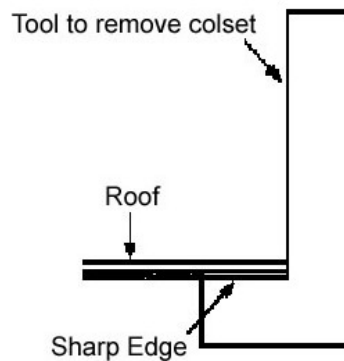
Figure 2: Tool to remove Colset

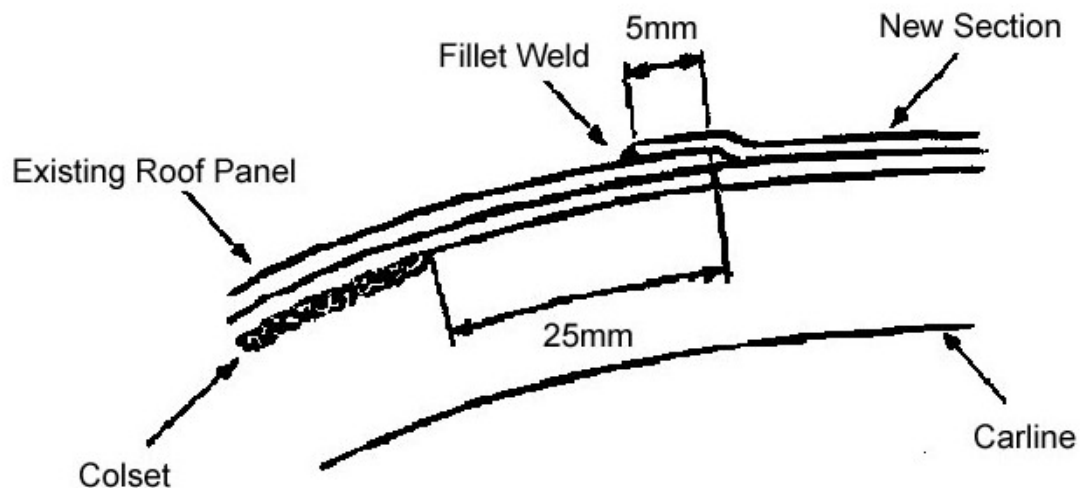
Figure 3: Local Shaping of New Roof Panel to fit Carline

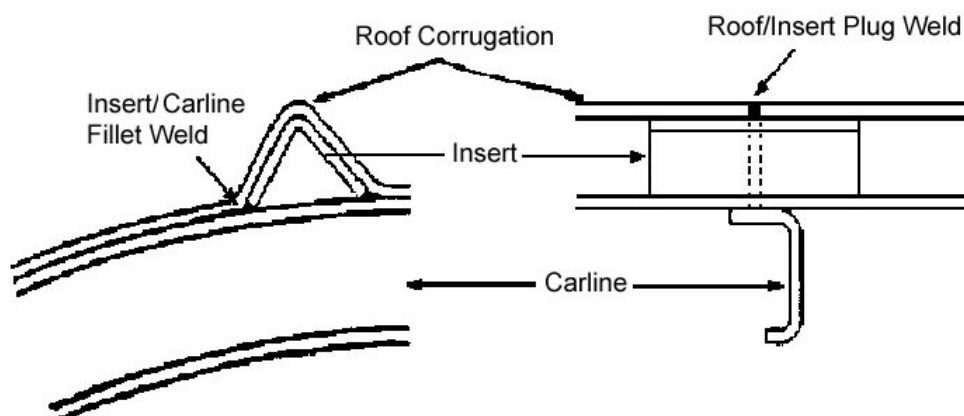
CRA0104

Figure 5: Fitting and Welding of Roof Sections at Carline/Corrugation

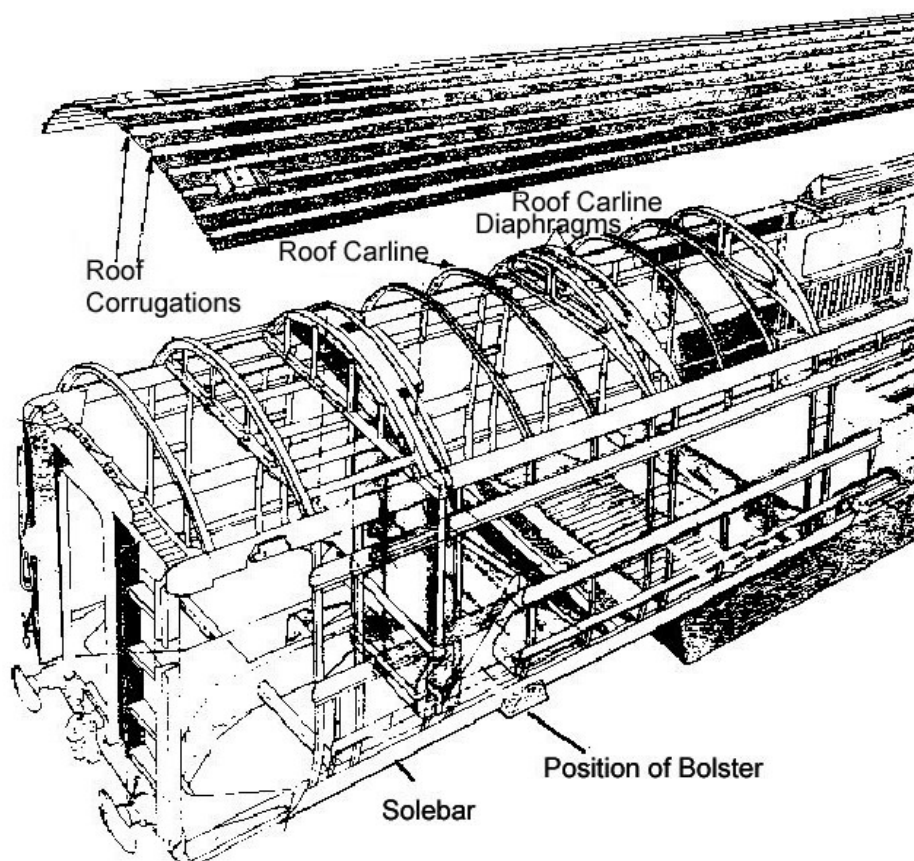
Figure 6: Sectional Drawing (Showing roof carlines)

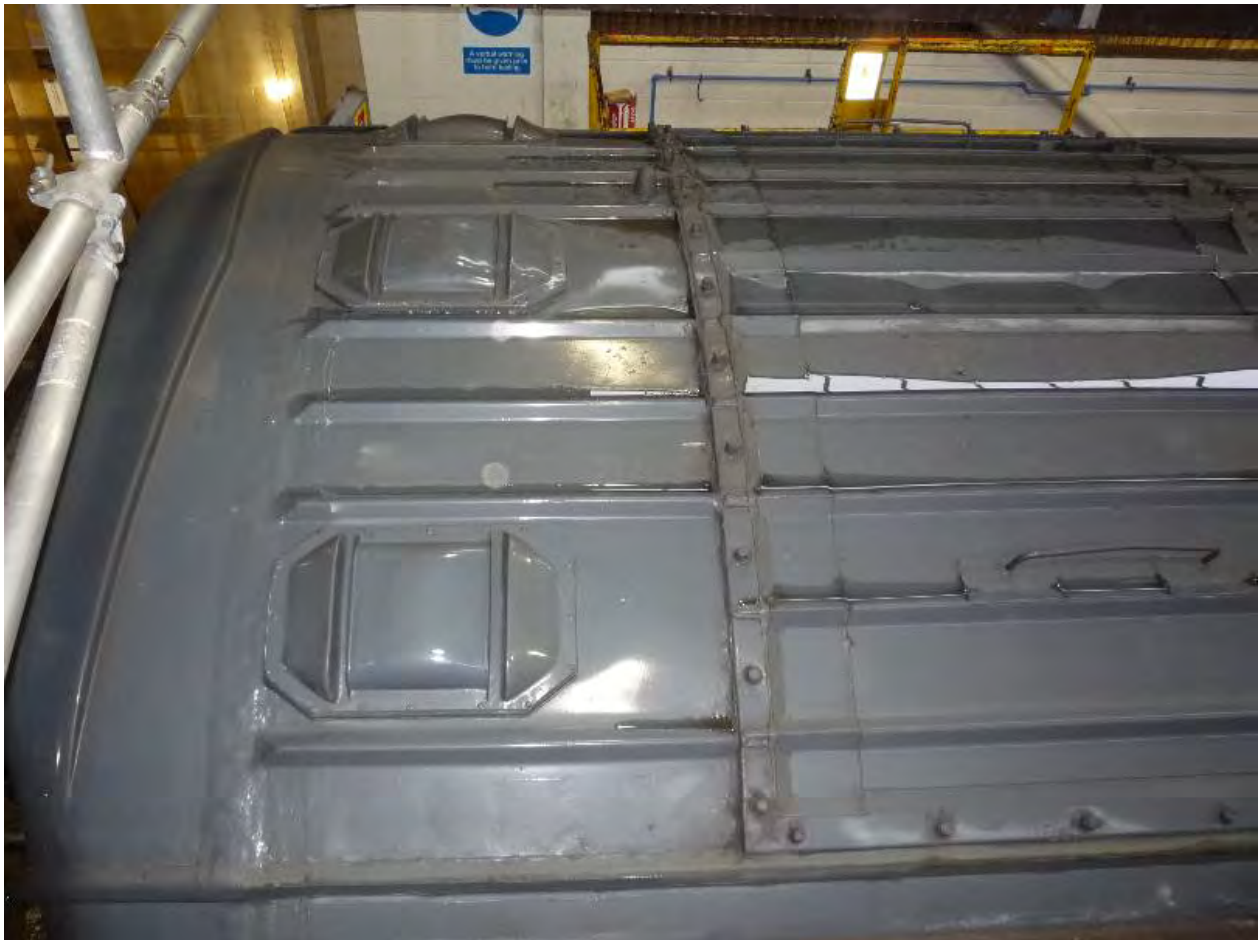
Examine the three ventilators in-situ for corrosion, any other defects and check they are securely fastened to the roof with all fasteners present.

Figure 1: Three Roof End Ventilators Mk 3A (quantities/vehicles are confirmed more accurately in the text)

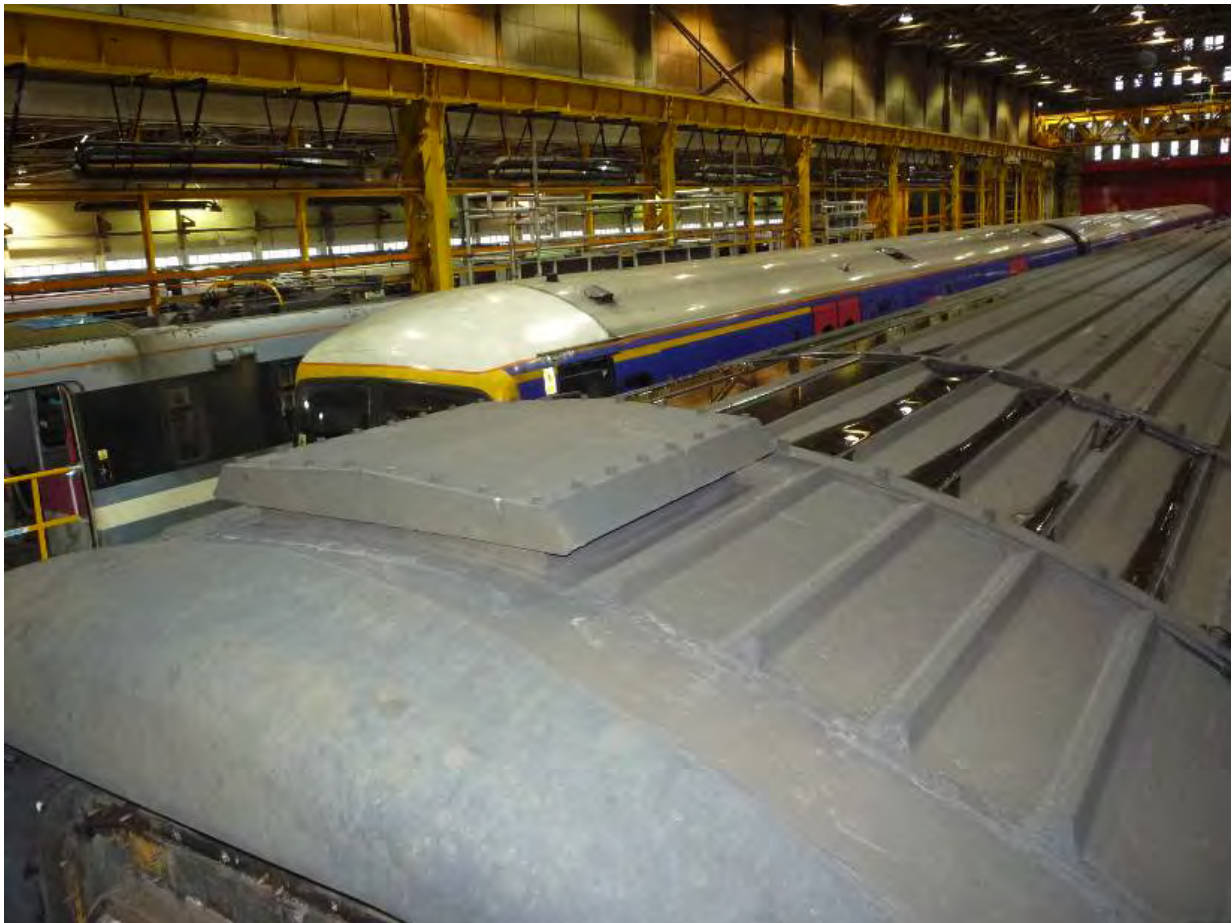
Examine the cowl for defects.

Figure 2: Roof End Cowl Mk 3B and HST (quantities/vehicles are confirmed more accurately in the text)

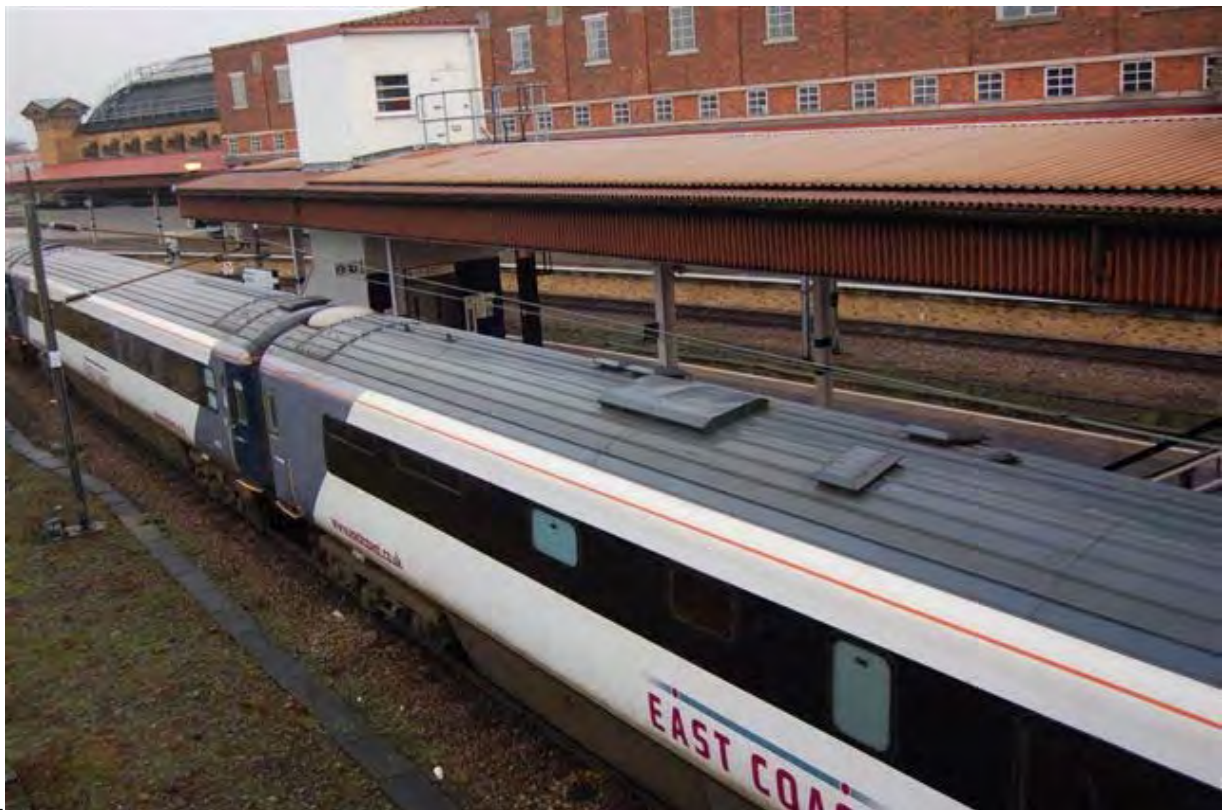
Examine each cowl for defects.

Figure 3: Catering Area Roof Cows on HST TBRF

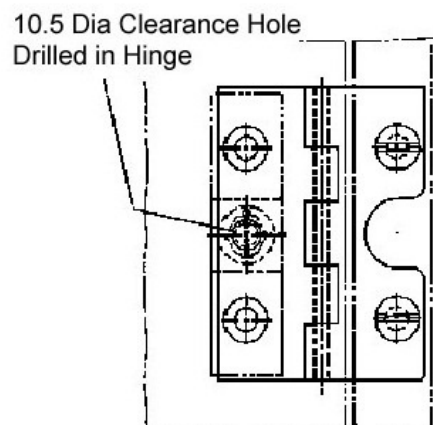
2. Eliminate flexible link as follows:
 - 2.1 Remove the hinge.
 - 2.2 Remove and scrap the flexible link.
 - 2.3 Drill the hinge as shown in Figure 1.
 - 2.4 Assemble the hinge to the panel as shown in Figure 1 (i.e. the other way round).
 - 2.5 Add taper washer (see Materials item 1) and M8 slotted nut.
 - 2.6 Tighten nut (see Torque Figures item 1) and further tighten to align split pin hole.
 - 2.7 Fit split pin and open out legs.

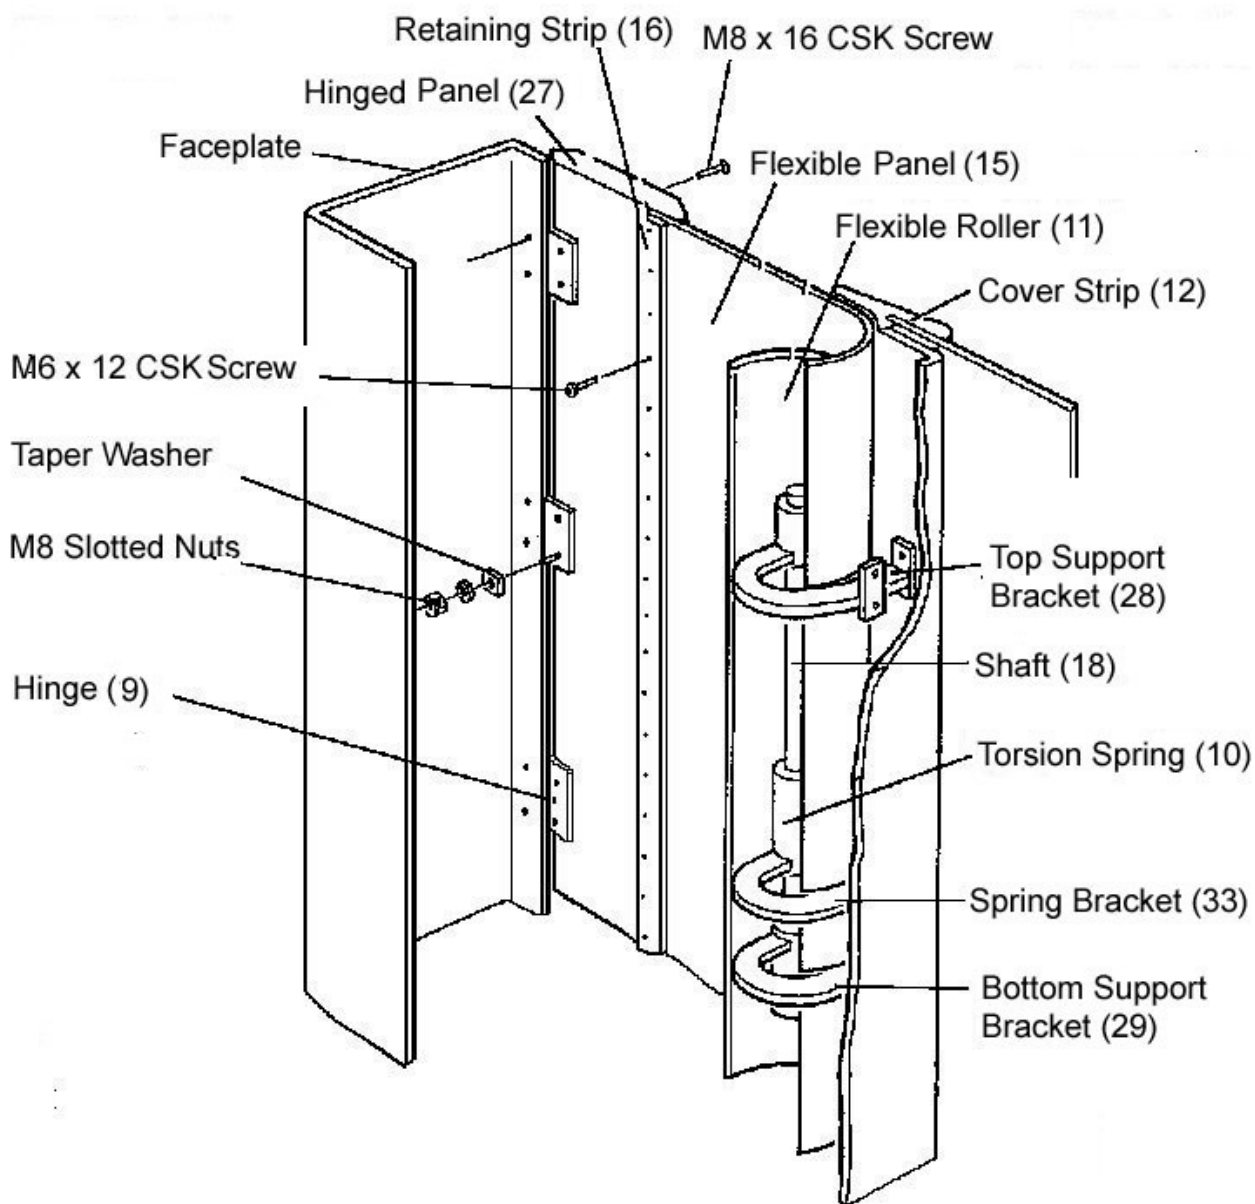
**Figure 2: Gangway Interior Panels**

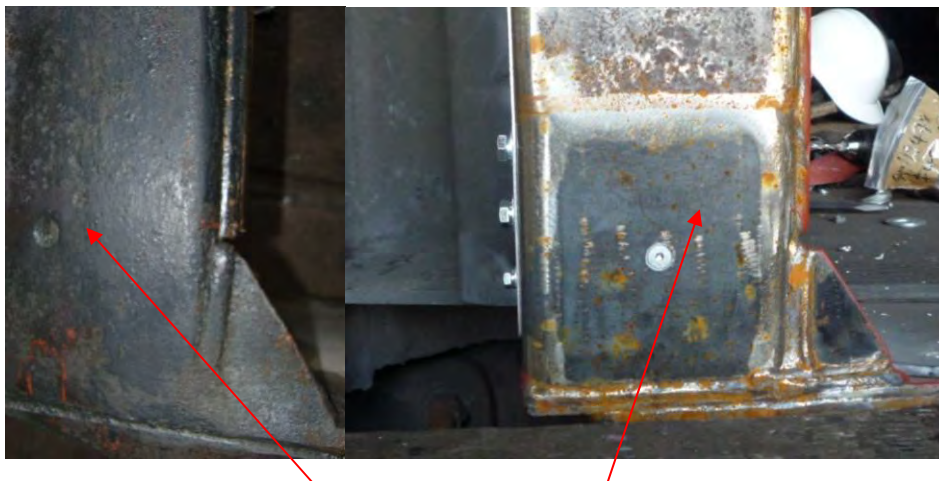
CV 0103

Figure 1: The left hand photo shows the standard arrangement not strengthened, the right hand photo shows the area strengthened.

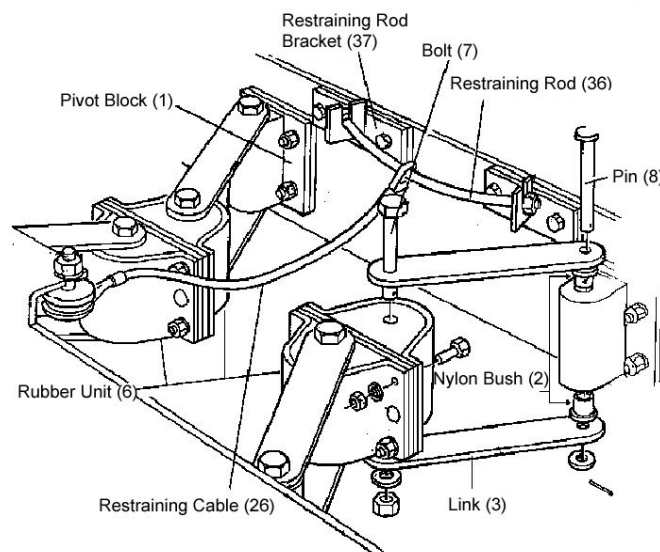
Figure 1: Arrangement of Flexitor Linkage

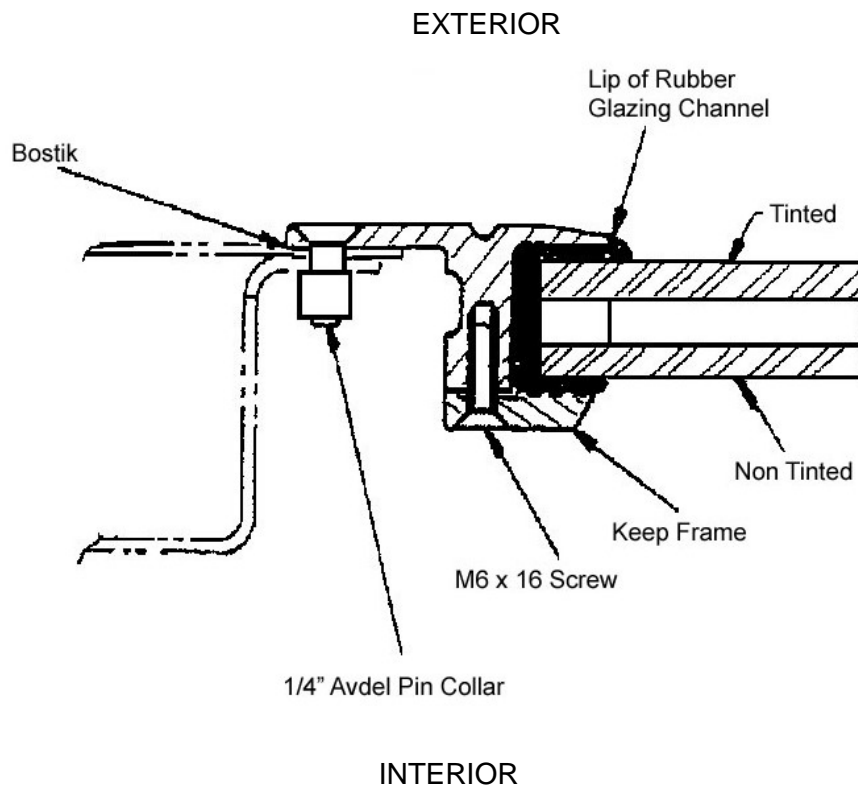
Figure 1: Sketch of Window Frame

- 2.9 Offer the keep frame to the window frame and fit all the set screws loosely (lightly grease screws prior to fixing). Tighten set screws evenly working from the centre and diagonally until fully tighten.

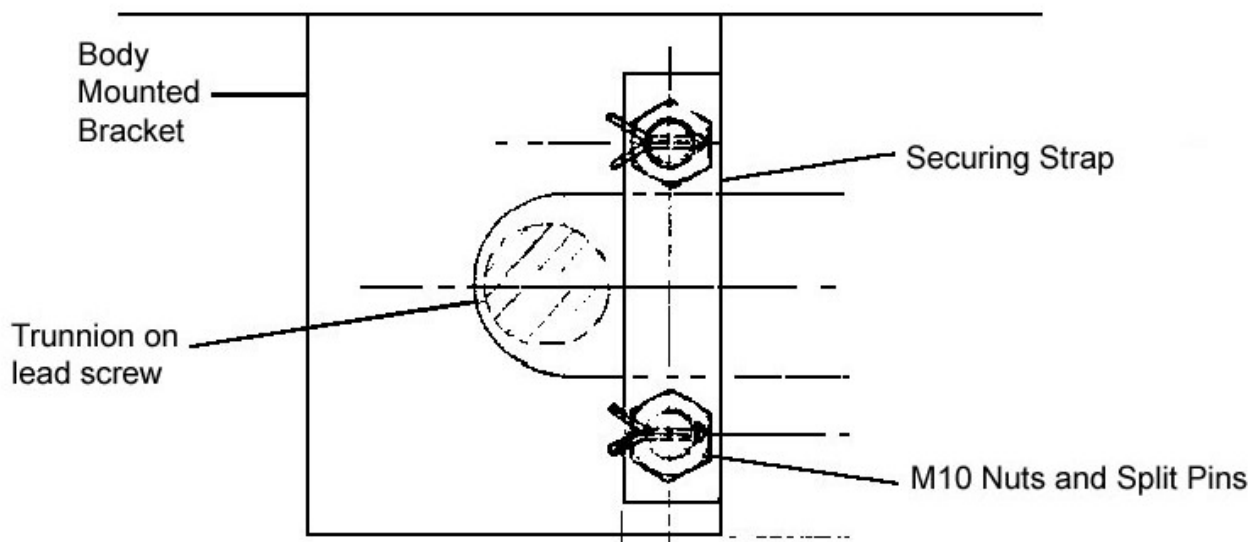
- 1.1 Remove the module as follows:
 - 1.1.1 Remove the plug from the socket at the rear of the module.
 - 1.1.2 Remove the the earth connection and the 2 securing pins from the front panel.
 - 1.1.3 Fit the handle to the square end (22mm across flats) of the winding screw.
 - 1.1.4 Operate the handle to wind out the module.
 - 1.1.5 Using suitable equipment take the weight of the module, taking care not to damage protruding drain tubes.
 - 1.1.6 Remove the two retaining straps on the trunnion holder (see Figure 1).
 - 1.1.7 Remove the stops on the ends of the roller support channels.
 - 1.1.8 Withdraw the module from the vehicle and remove the cells.

Figure 1: Screw Attachment to Vehicle Module

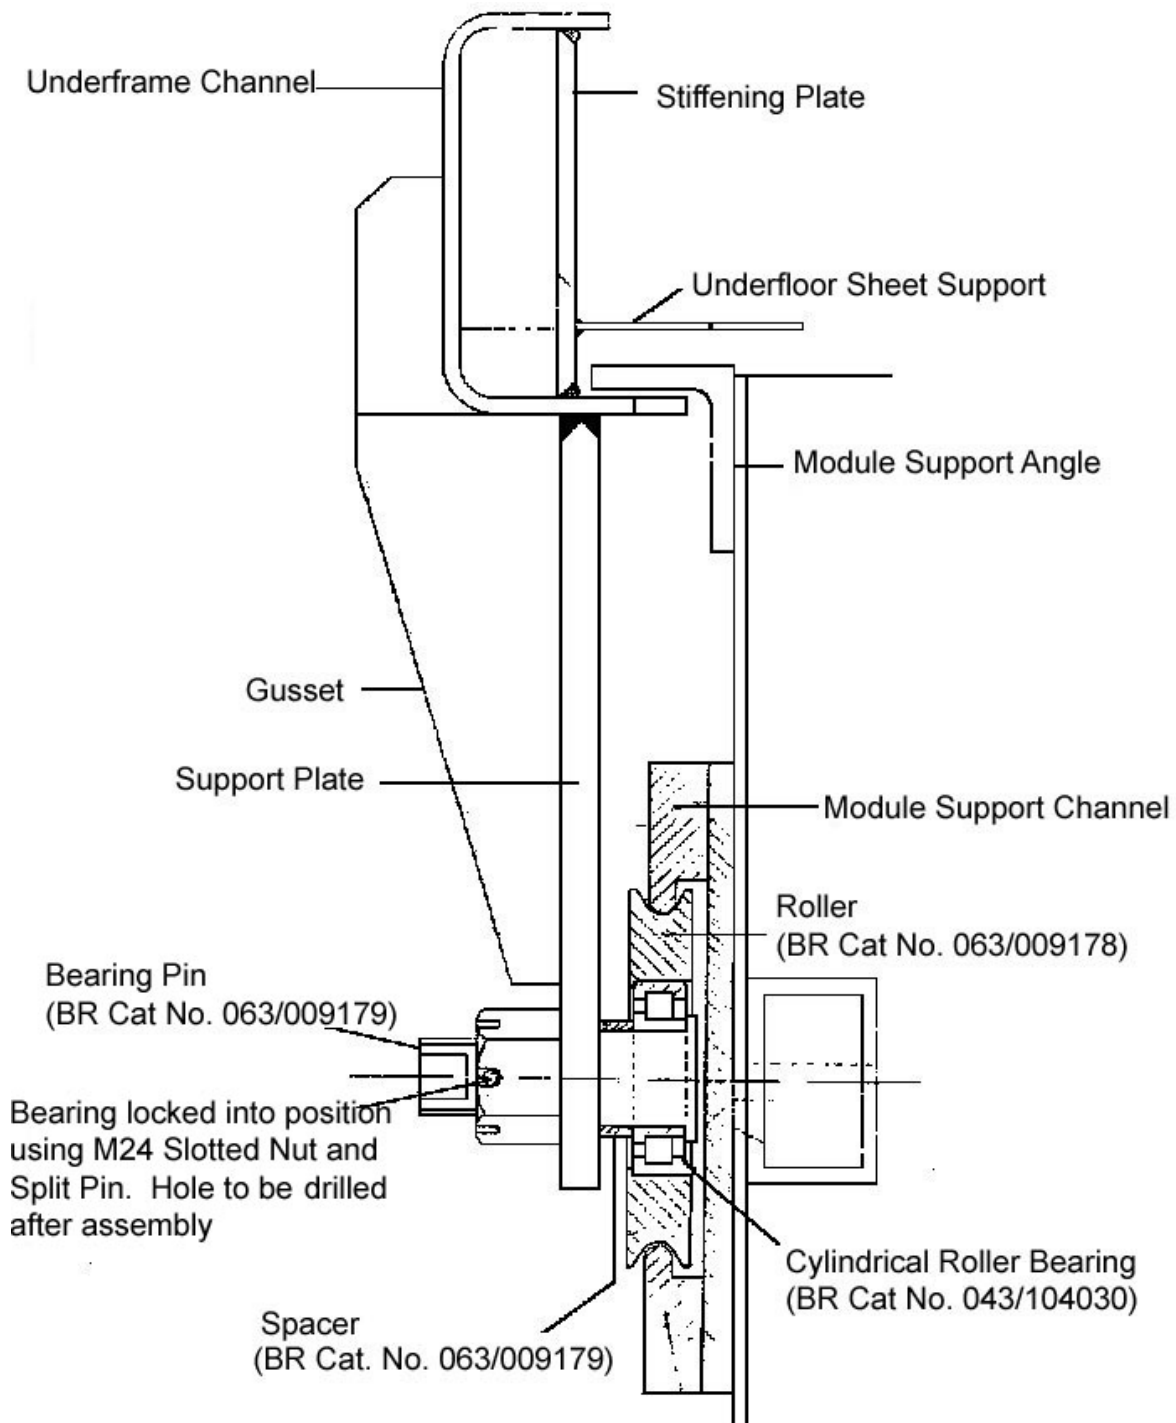
EB 0006

Figure 2: Battery Module Rollers and Supports

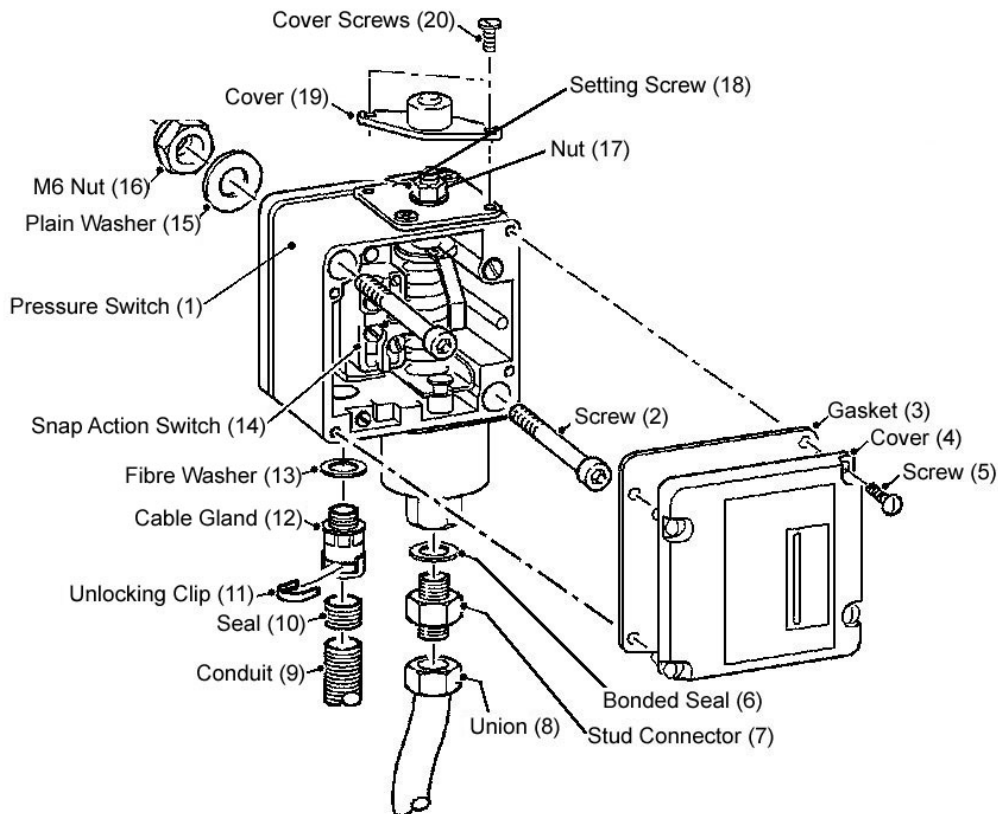
EH 5203

Figure 1: Typical View of Pressure Switch
