VEHICLE OVERHAUL INSTRUCTION

PB/VI2133

PORTERBROOK MARK 3 LOCO HAULED COACHING STOCK AND HST TRAILER VEHICLES

Issue: 5

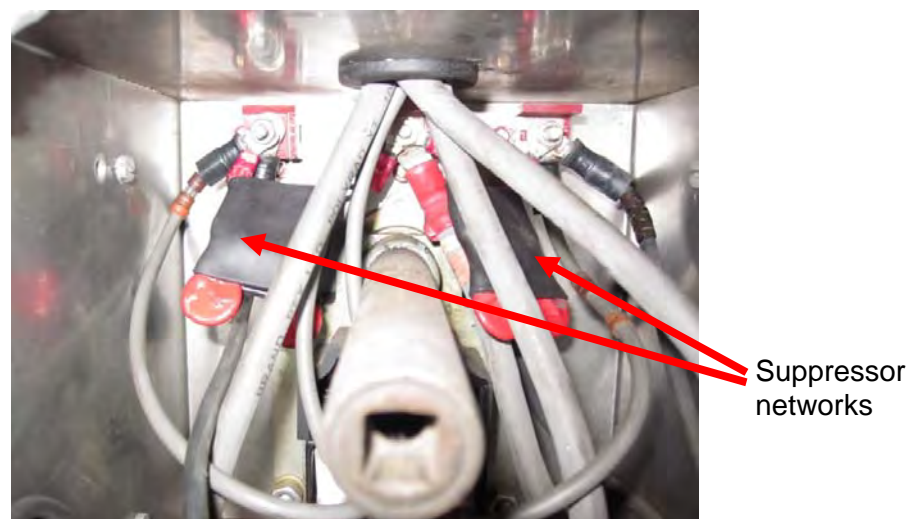
1. Trip MCB TLCD to 'OFF' and place the auxiliaries switch to 'OFF'.
2. Open the cupboard that houses the through lighting controller. This is located at the No.1 end of the vehicle.
3. Check the operation of the lighting controller. If found to be defective see Arising Work.
4. Remove the four screws securing the lighting controller front panel. Withdraw the front panel.
5. With the lighting control panel removed, it will be observed that three terminals are present (see Figure 1).

Figure 1: Terminal Connections

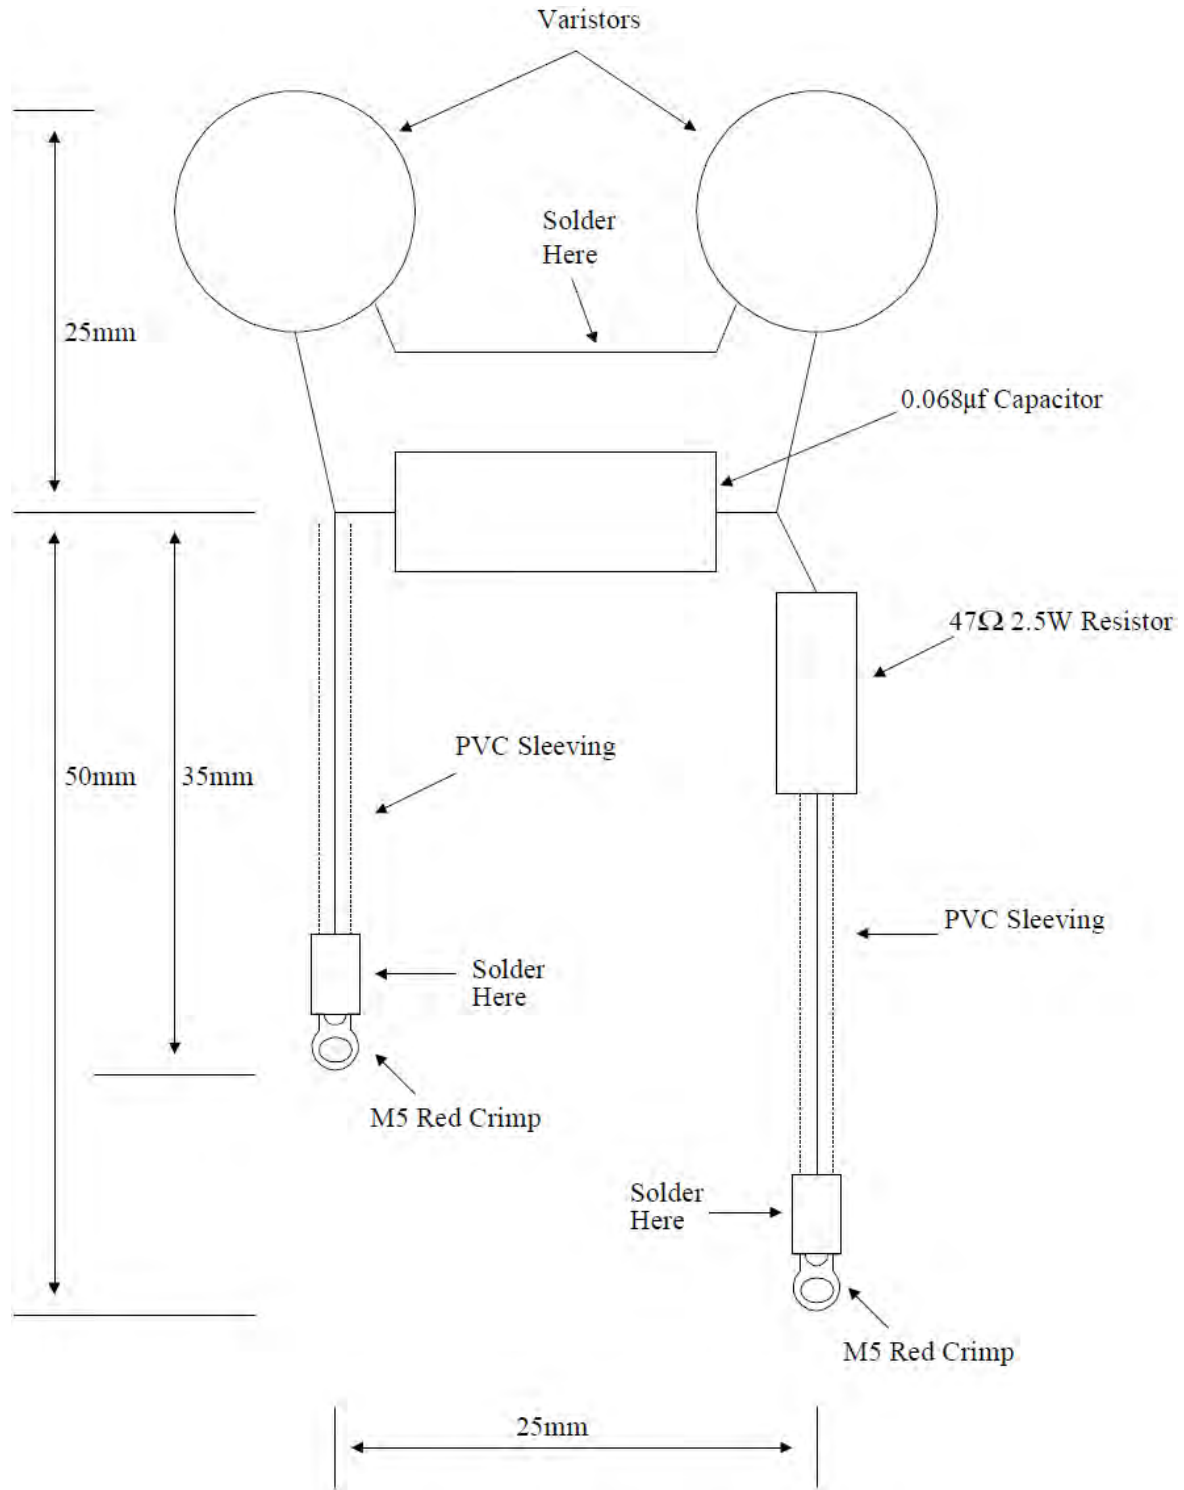
EL 0125

Figure 2: Varistor (Mickey Mouse) Suppression Network

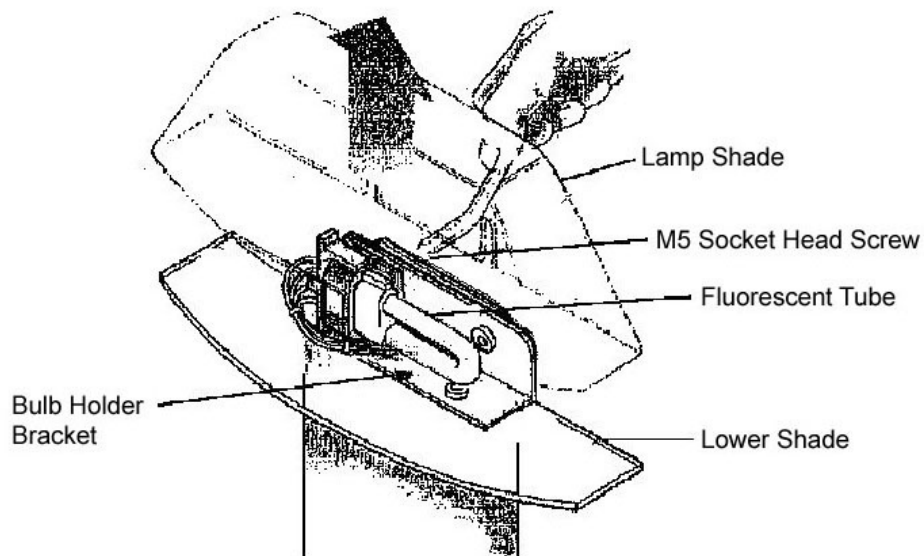
1. Remove the lamp shade by loosening two M5 socket headed bolts with an Allen key (see Figure 1).

Figure 1: Removal of Lamp Shade

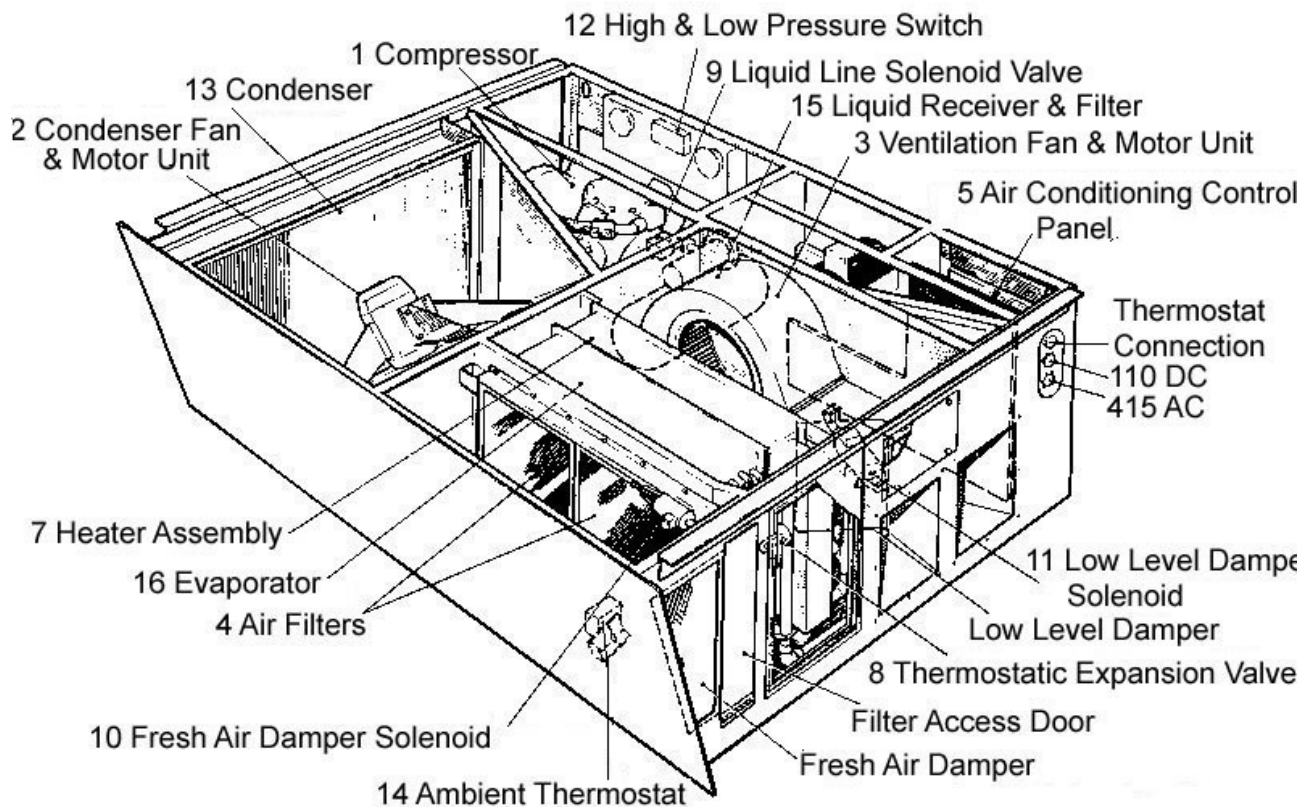
HA 0109

Figure 1: Stones UP31 Air Conditioning Module

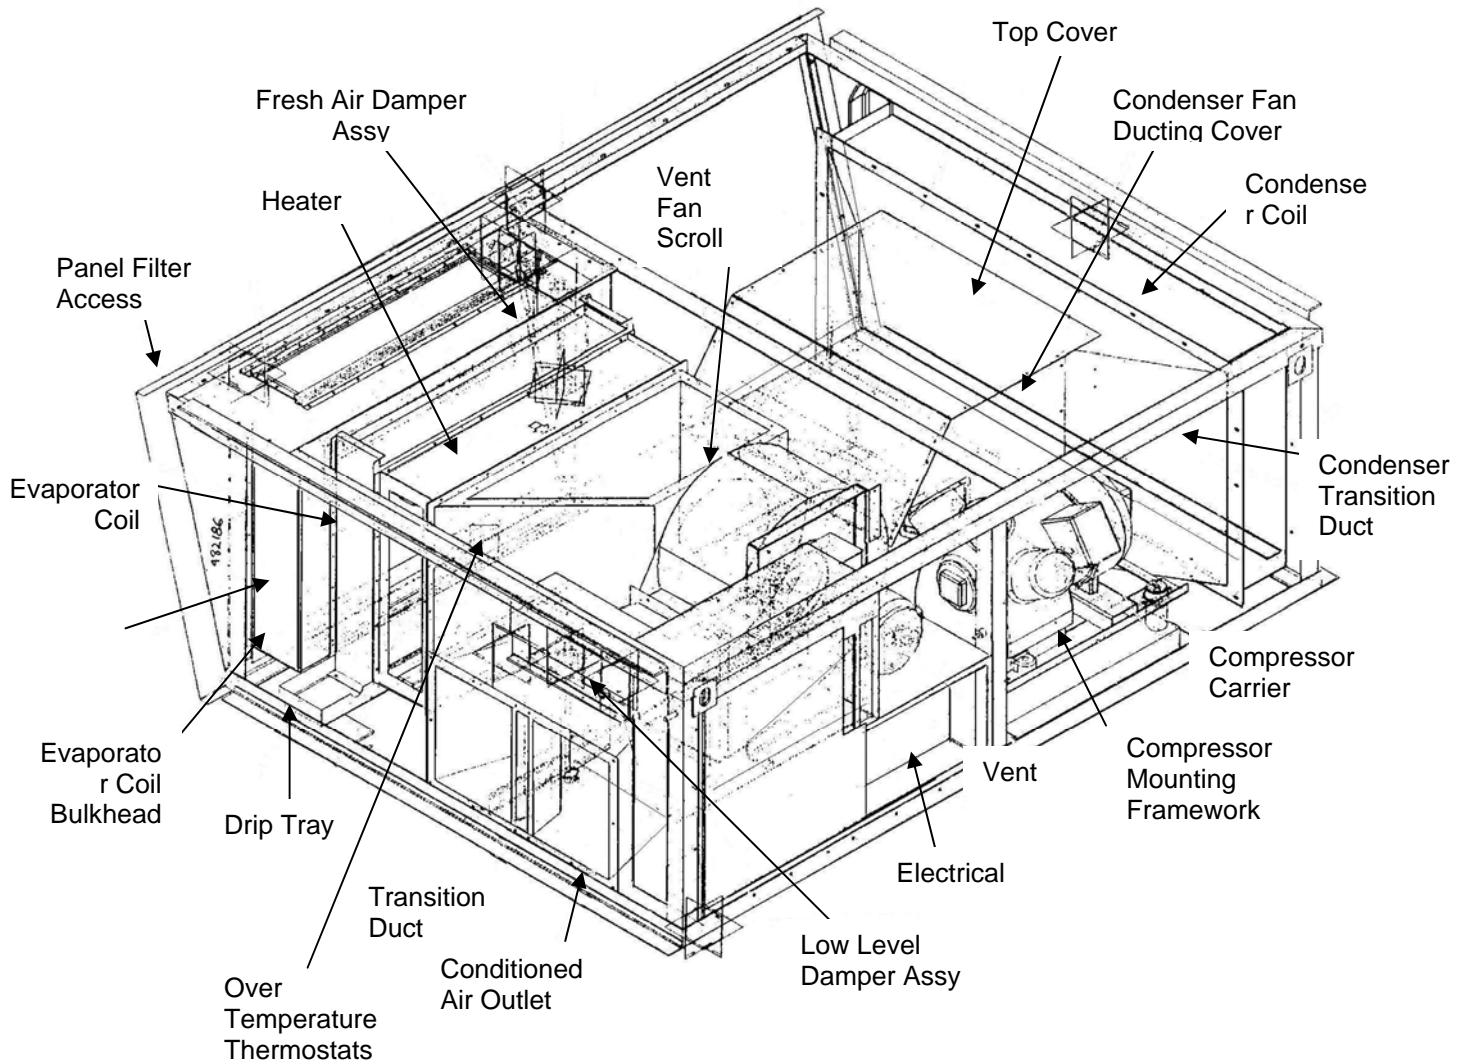
HA 0109

Figure 2: Wabtec Vapor Stone Air Conditioning Module

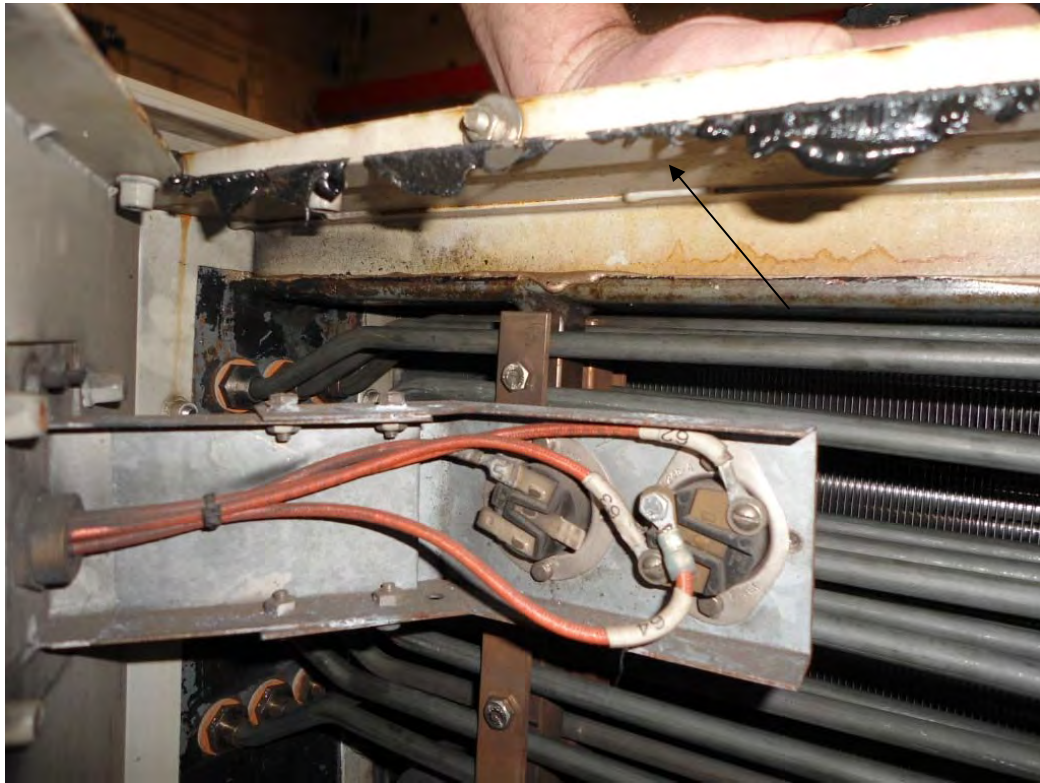
HA 0109

Figure 3: Typical View of Over-Temperature Thermostats in Situ

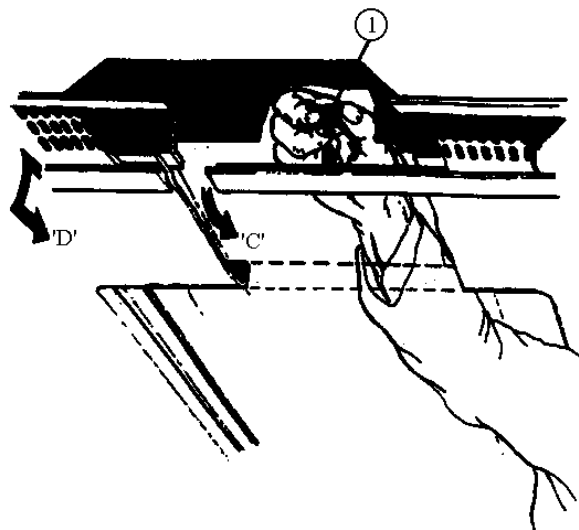
Place hand into diffuser aperture, reach toward air ventilation panel and locate nuts (1). Loosen until trim/retaining strips are lowered sufficiently to swing slightly toward centre of carriage (as arrow 'C'). Ease ventilation panel outwards and down until edge is clear of trim, pull towards centre and remove (as arrow 'D').

Figure 1: Removal of Ceiling Grille

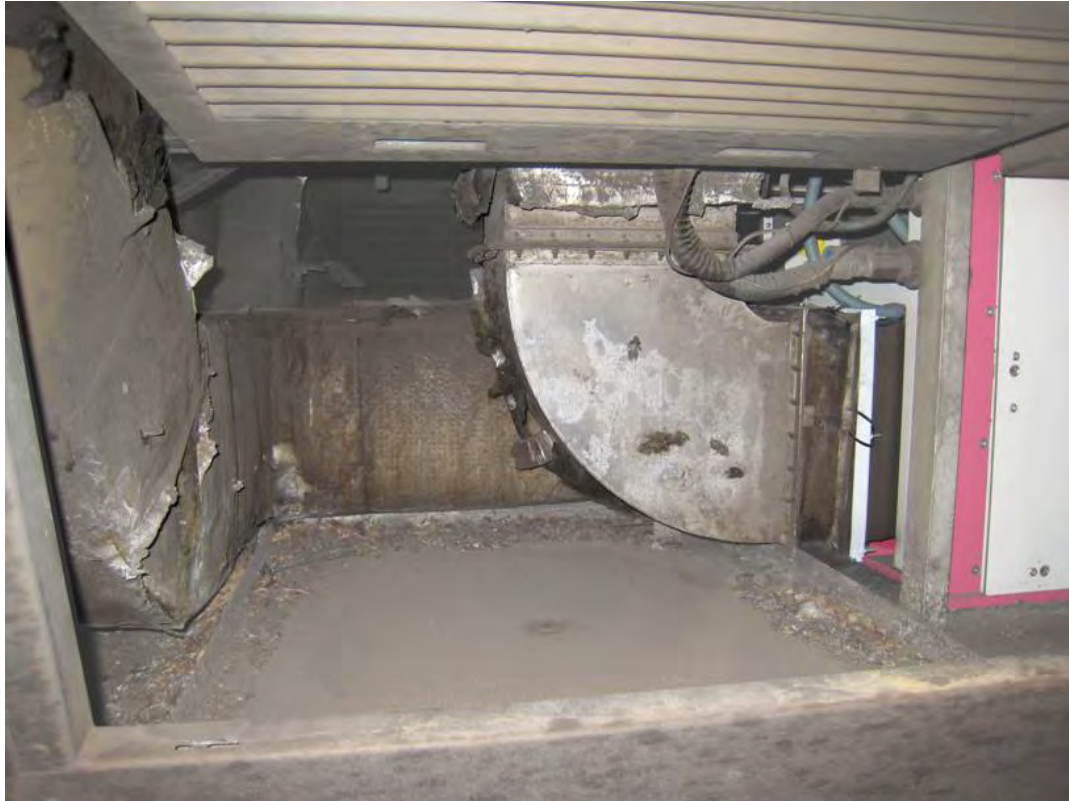
HD 8002

Figure 1: Typical View of Air Conditioning Fixed and Flexible Ducts in the Underskirt

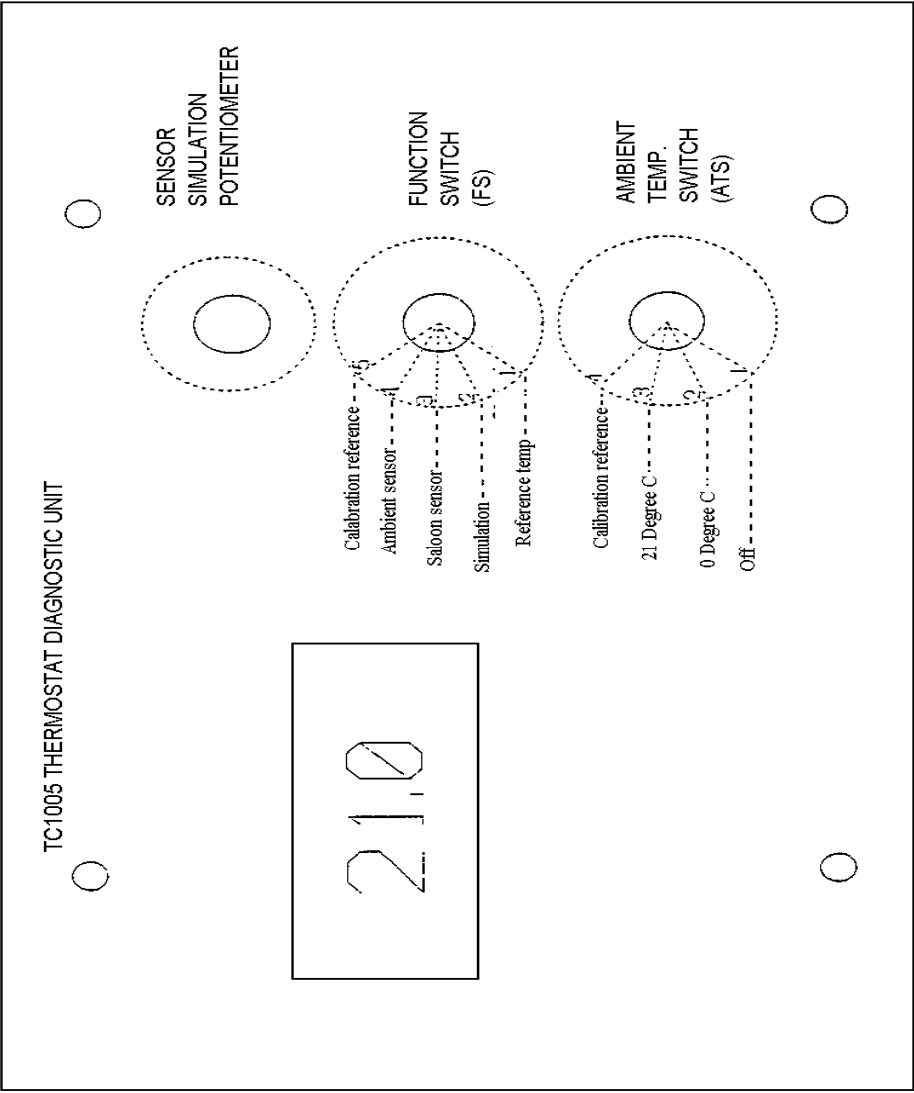
HZ 0102

Figure 1: TC 1005 Thermostat Diagnostic Unit

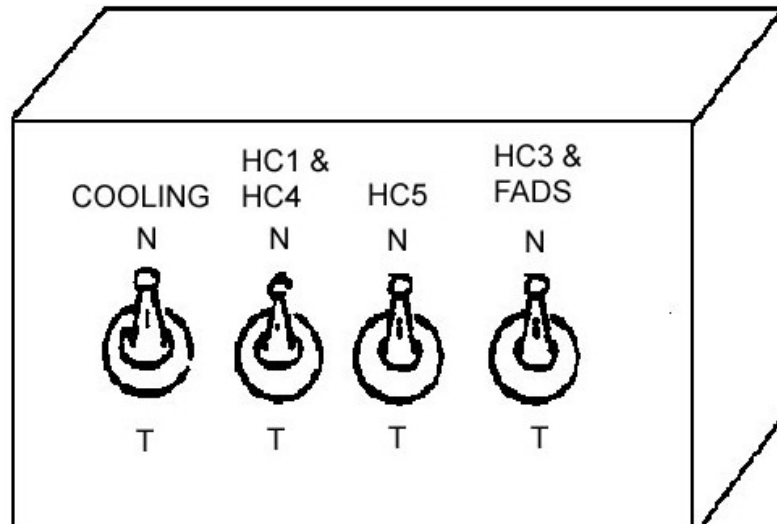
HZ 8003

Air Conditioning Testbox Electrical Circuit

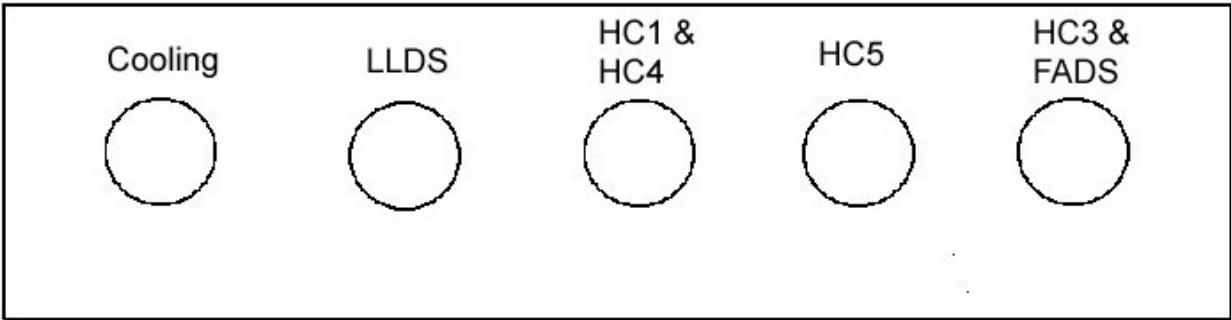
HZ 8003

Indicator Light Unit Electrical Connections

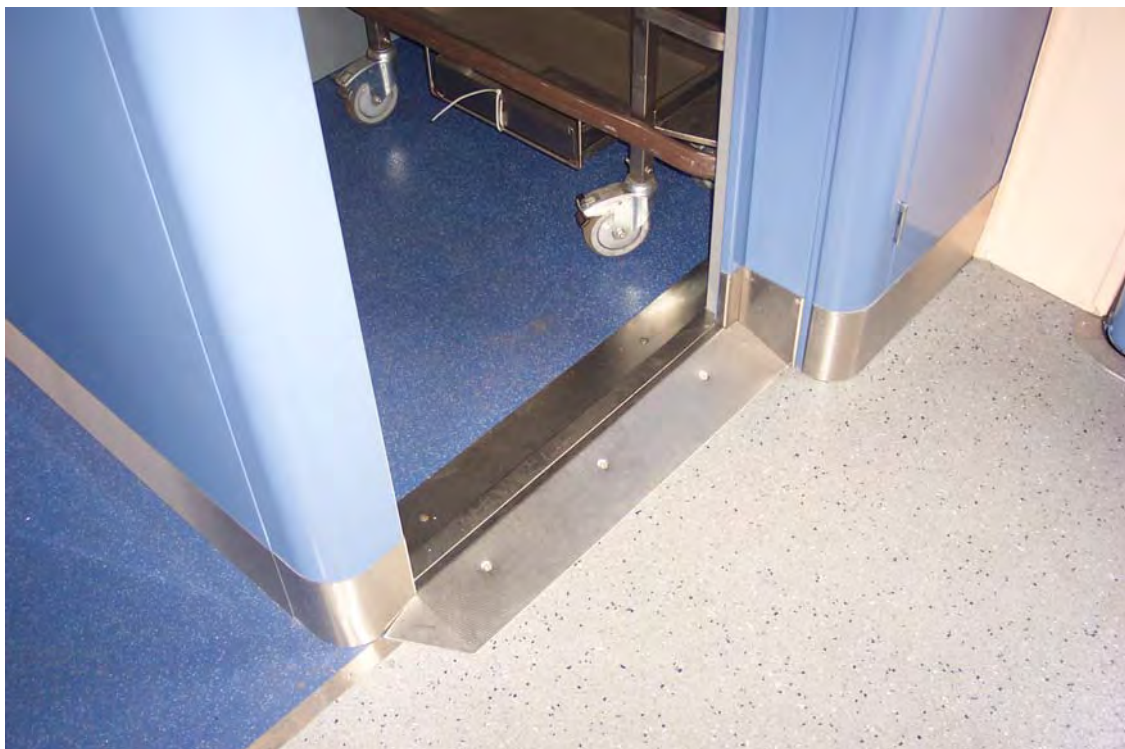
Figure 1: Kitchen Door Treadplate

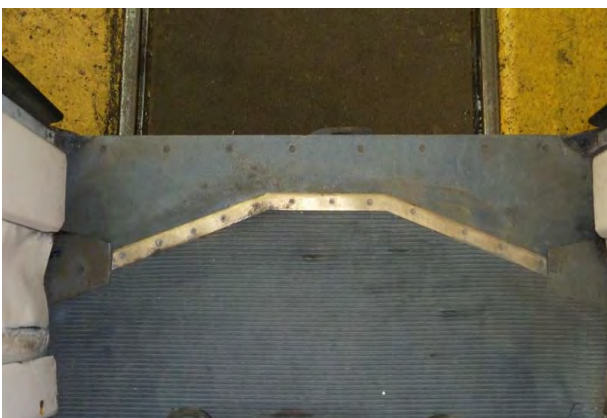
Narrow Profile Treadplate with Side Wings

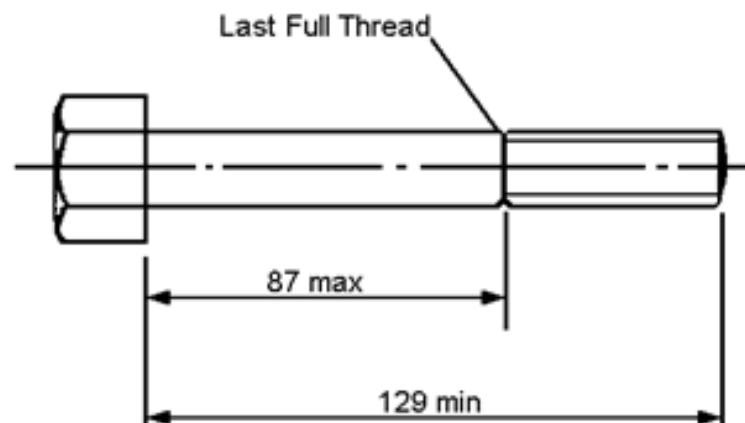
Figure 1

3. Remove minor flashover damage.
3. Change M/A set and fit new fasteners as described in step 15 of this job. Overhaul MA set in accordance with the specified documents (see Reference Documents items 1 or 2). Refit and secure the underframe removable panel in accordance with the specified document (see Reference Documents item 3).
4. Renew all brushes.
13. Renew the defective components.
- 15.1 Reject any defective new mountings.
- 15.2 Remove any projections from mating surfaces.
- 15.7 Reject any bolts which do not comply with Figure 1.

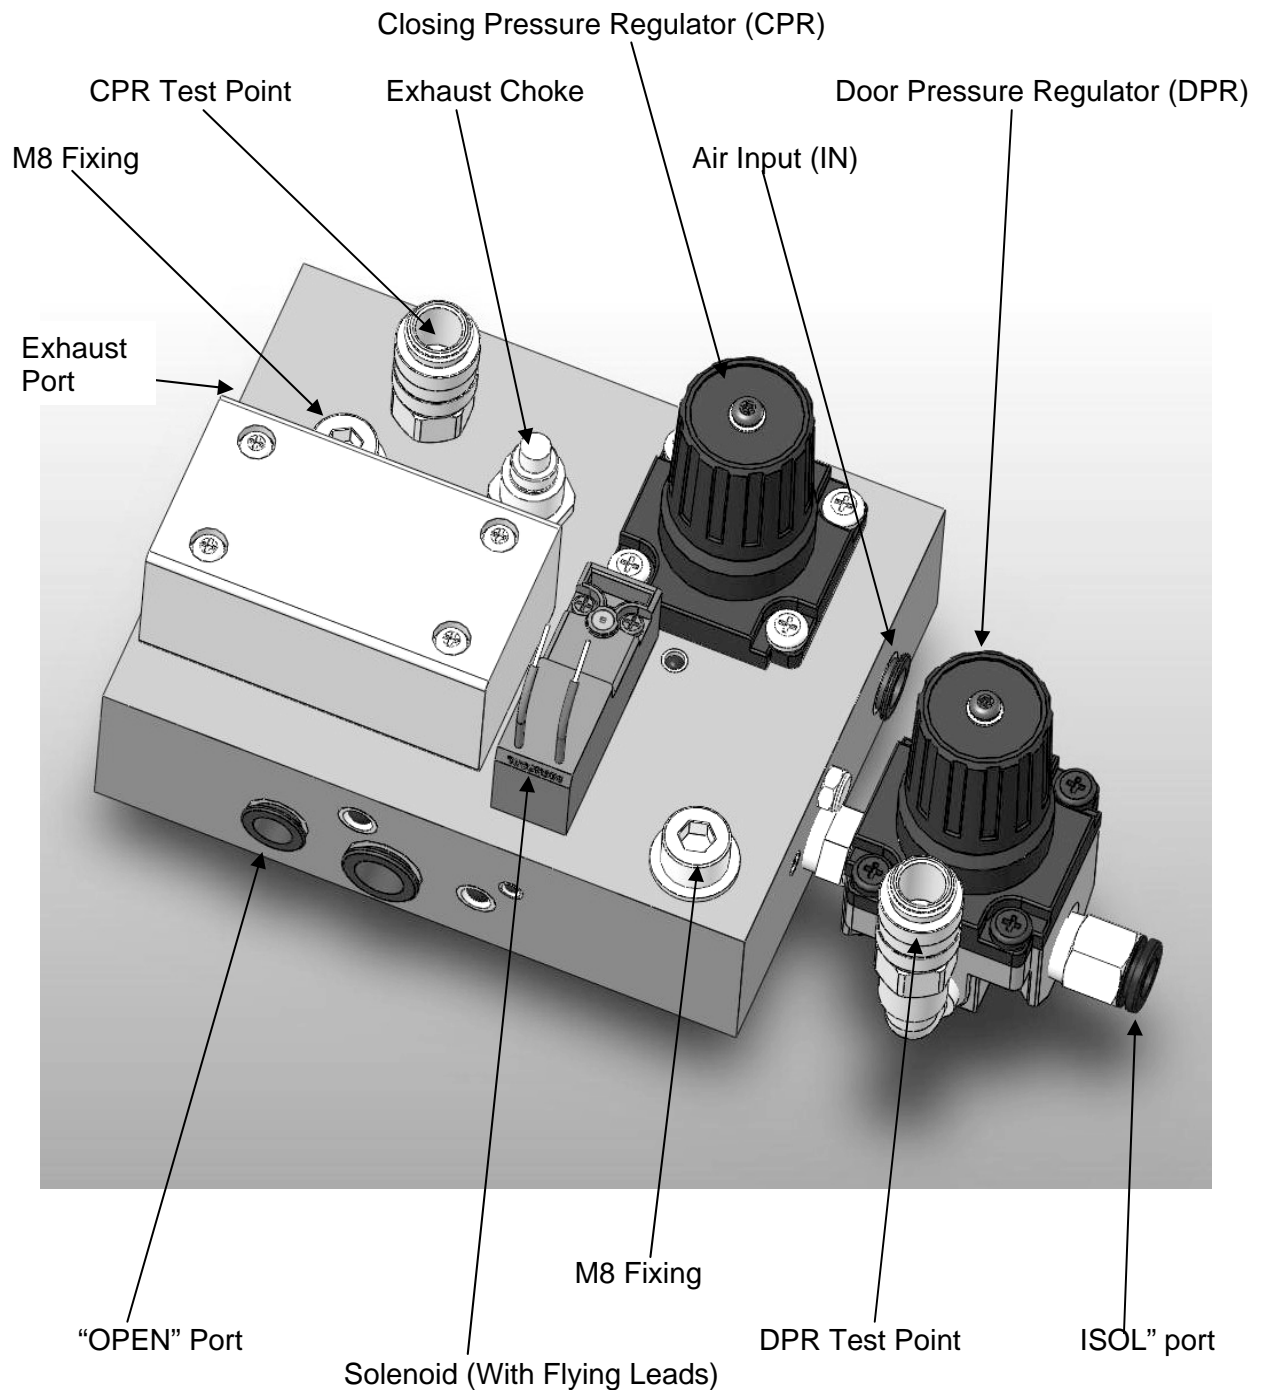
OC 0617

Figure 2: Modified Type Door Control Module

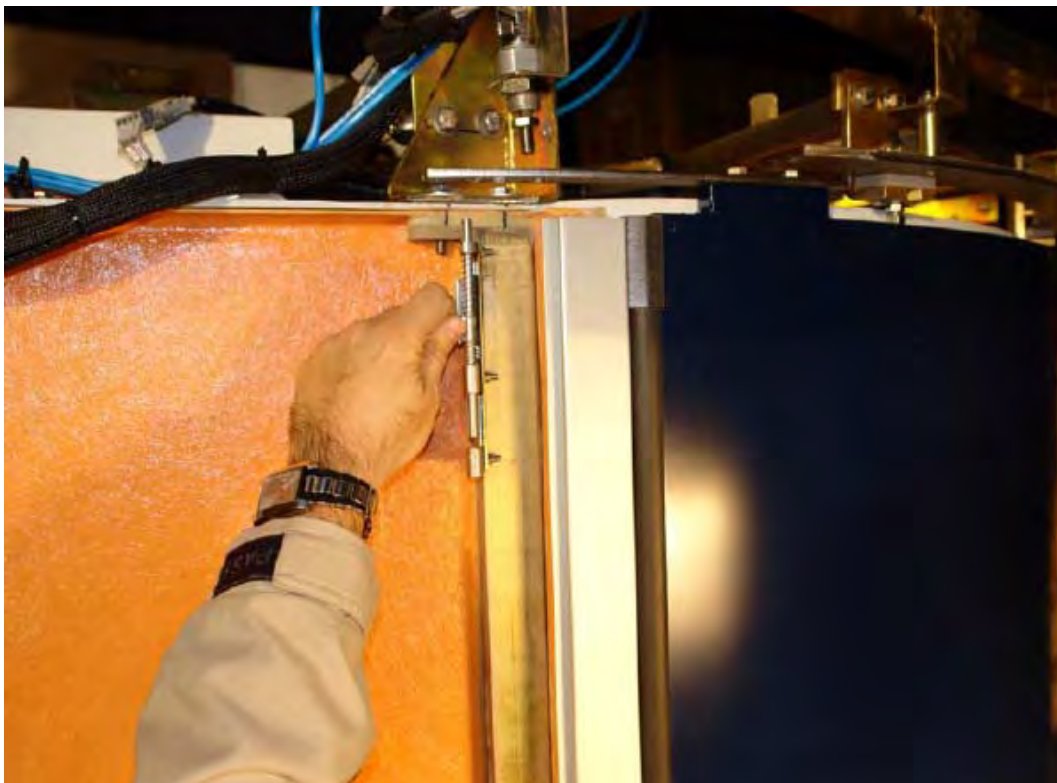
Figure 2: Manual Locking Bolt

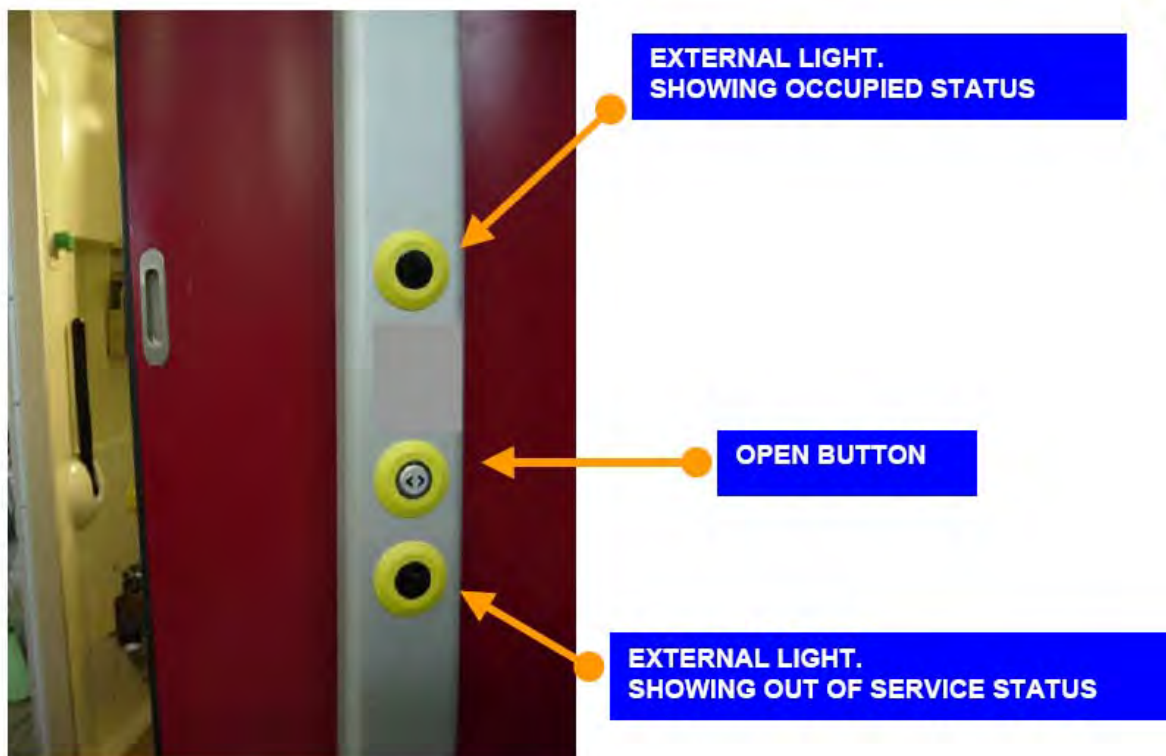
NOTE 5: If the pressure is incorrect the pressure switch (see Figure 1) will automatically isolate the door system.
 - 5.3 Check the control panel for air leaks.
 - 5.4 Close and lock exterior access panel.
6. Test the power operation of the door as follows:
 - 6.1 Press the external “open” pushbutton (see Figure 3).

Figure 3: External Pushbutton and Indicators

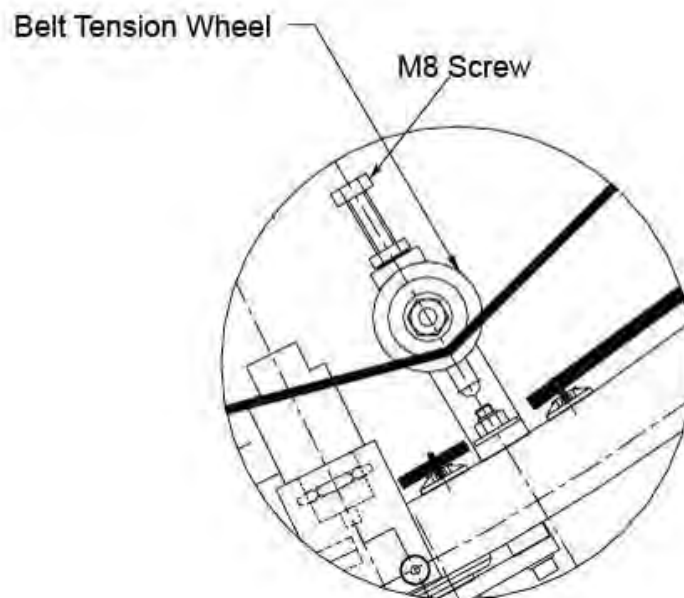
1. Loosen the locknut and M8 screw with an 13mm spanner.
2. Release the clamps securing the belt to the carriages.
3. Remove the belt from all the guide wheels.
4. Thread the new belt (see Materials item 15) onto the guide wheels.
5. Secure the belt to the carriages with the clamps.
6. Locate the belt on the tension wheel.
7. Adjust the tension in accordance with Procedure B.

Figure 2: Sprocket Belt Tensioner

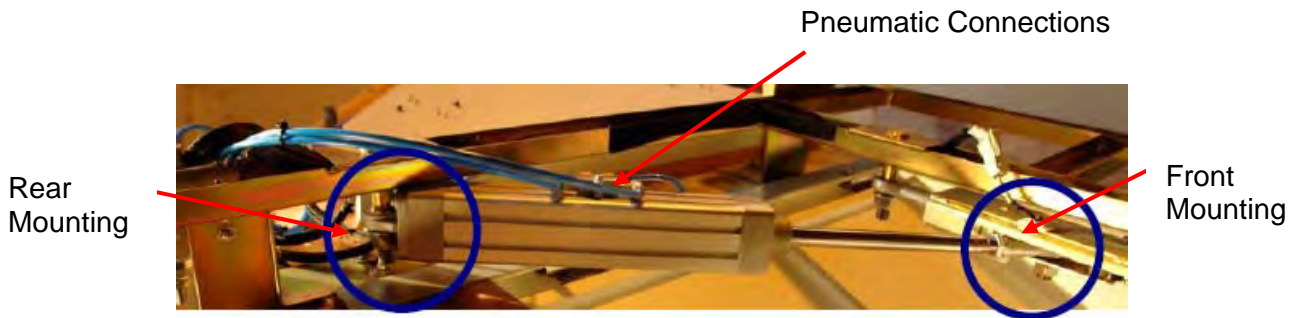
Figure 4: Door Cylinder Mountings

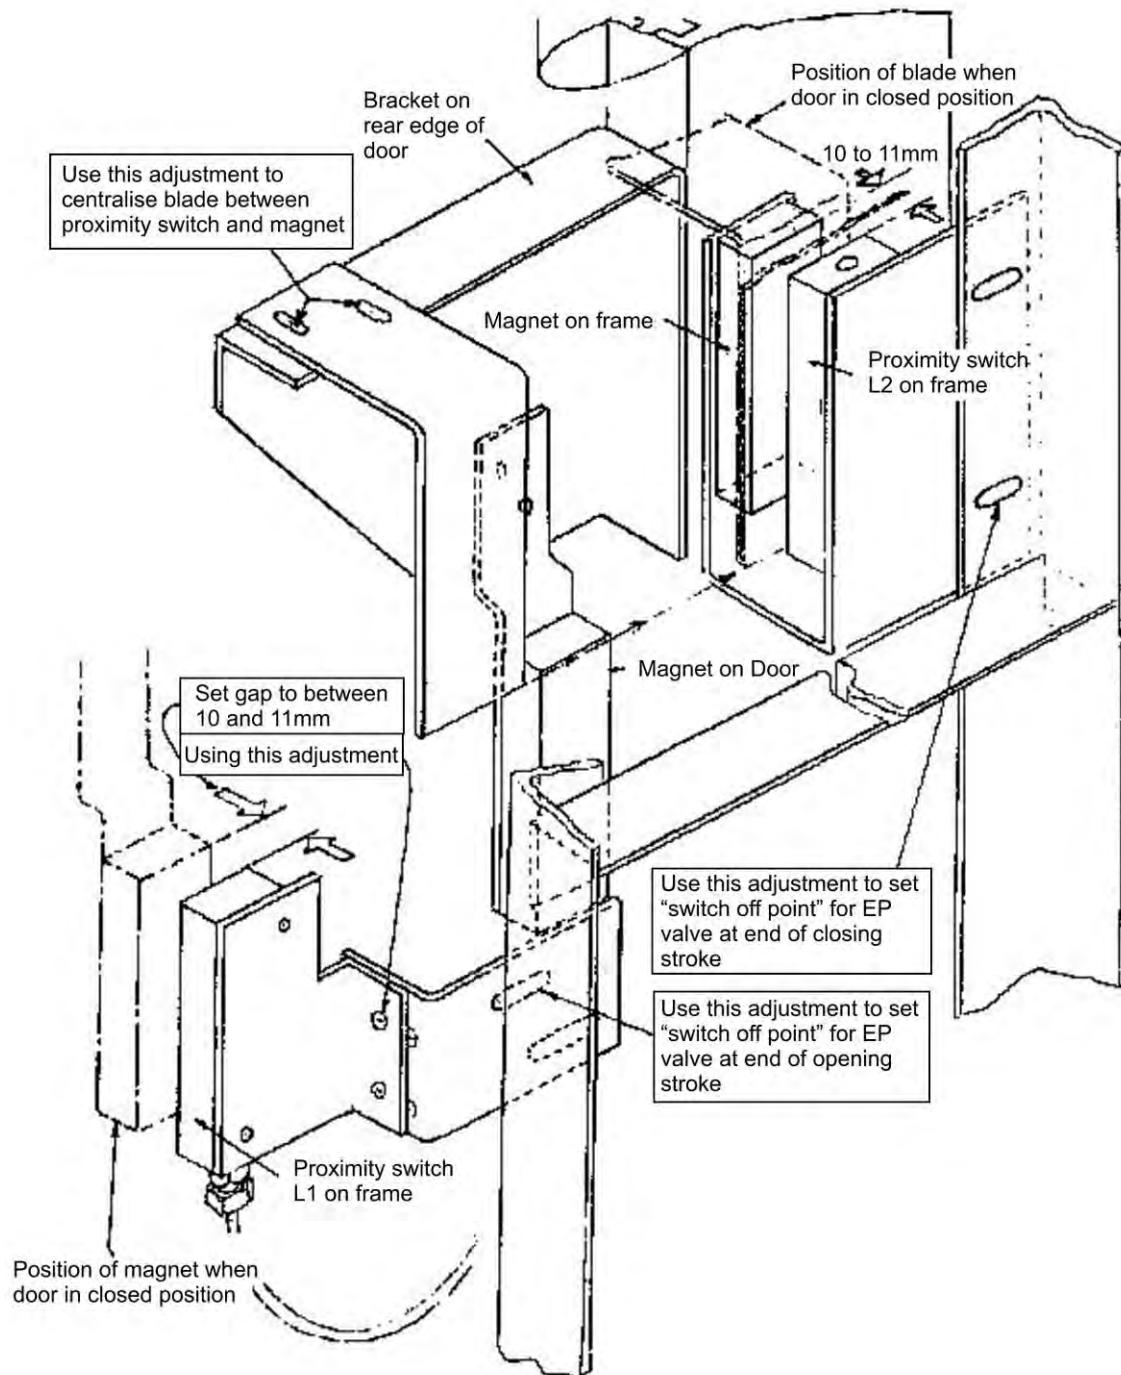
OJ 0138

Figure 3: Adjustment of Proximity Switches and Magnets

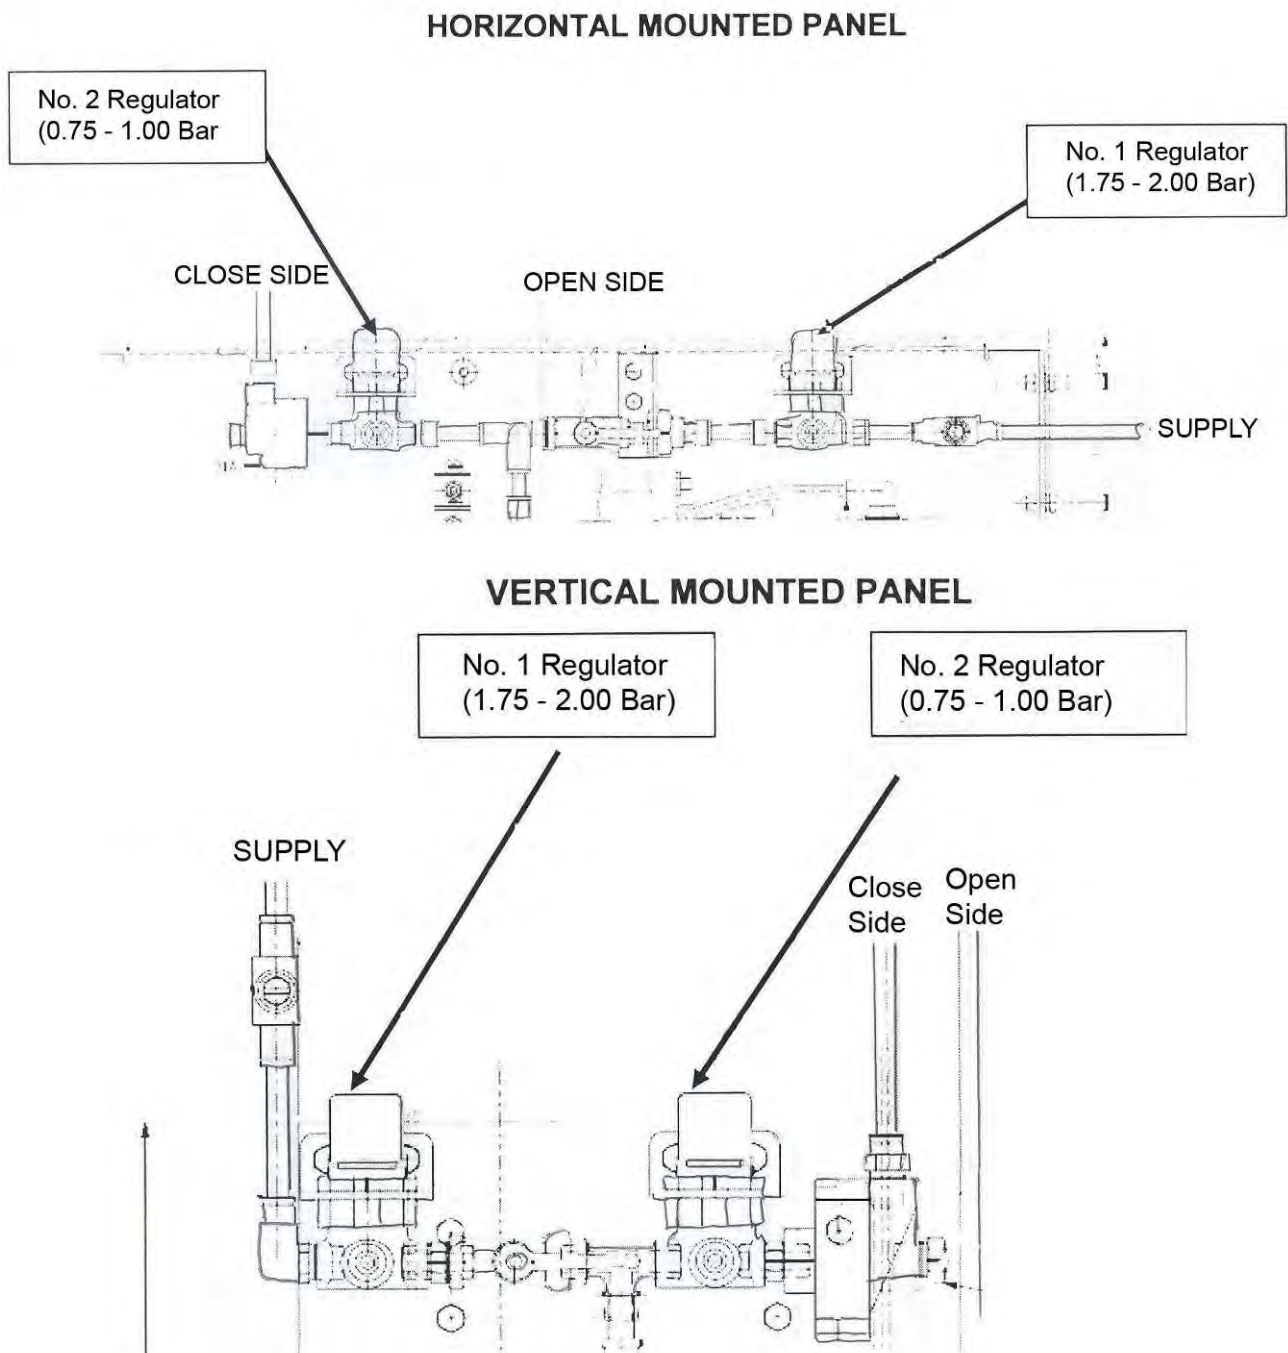
OJ 0138

Figure 4: Door Pressure Regulator Valves for Wabtec Rail Control Panel

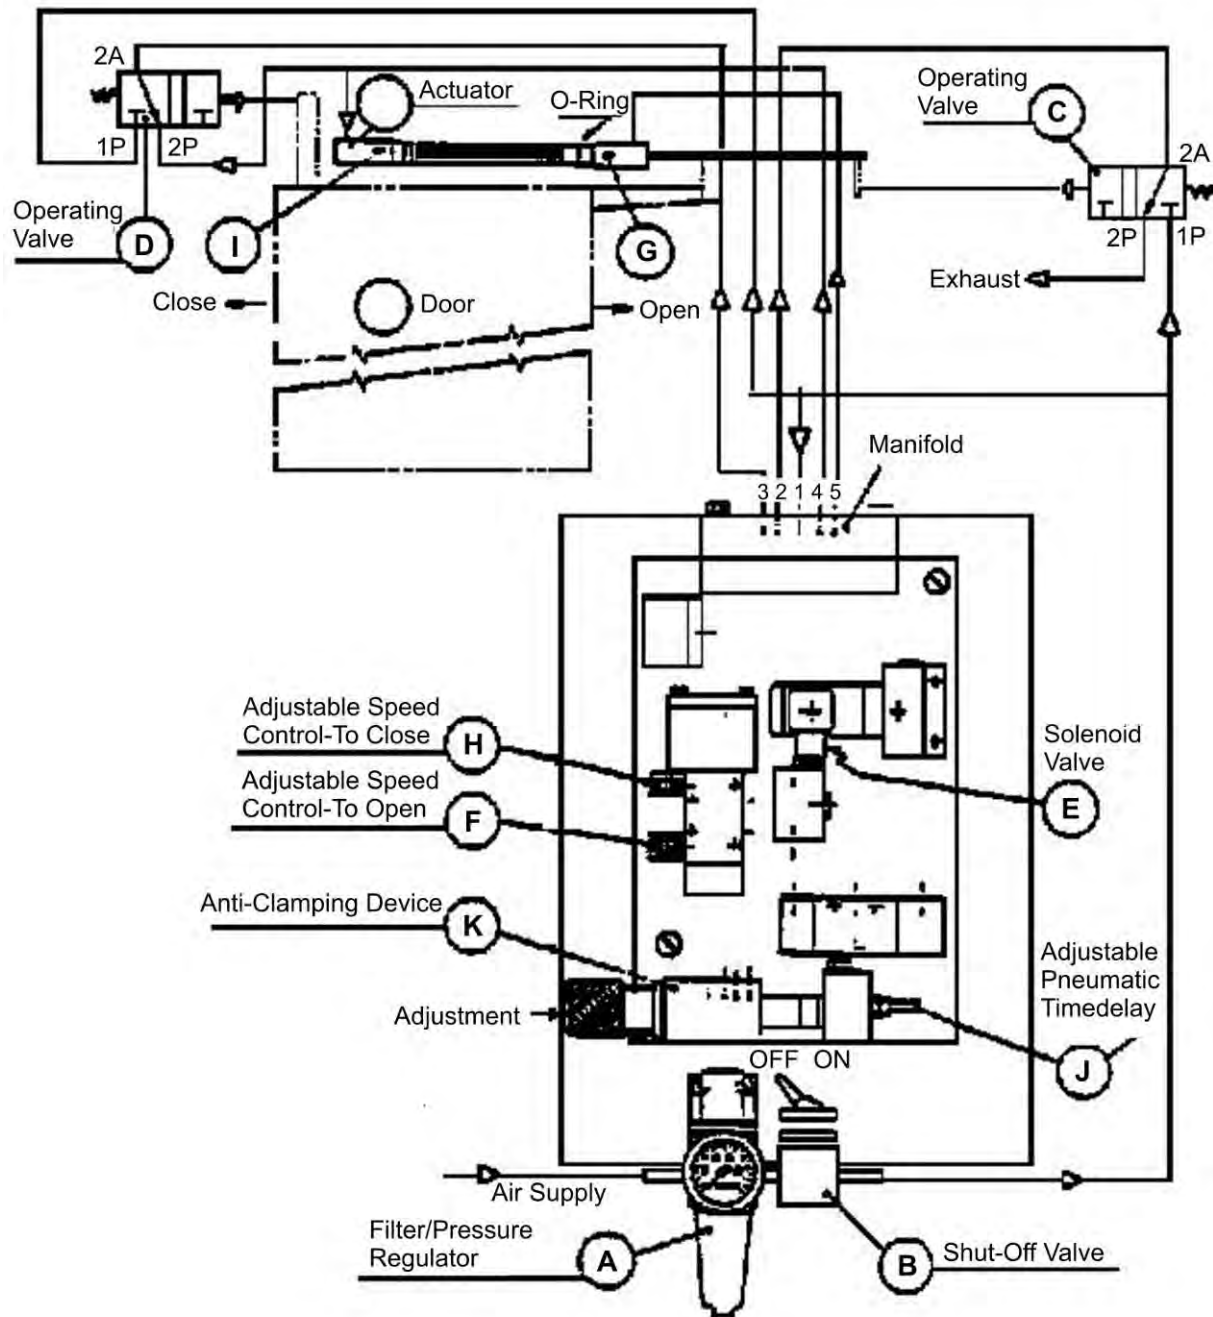
OJ 0138

Figure 5: Tebel System

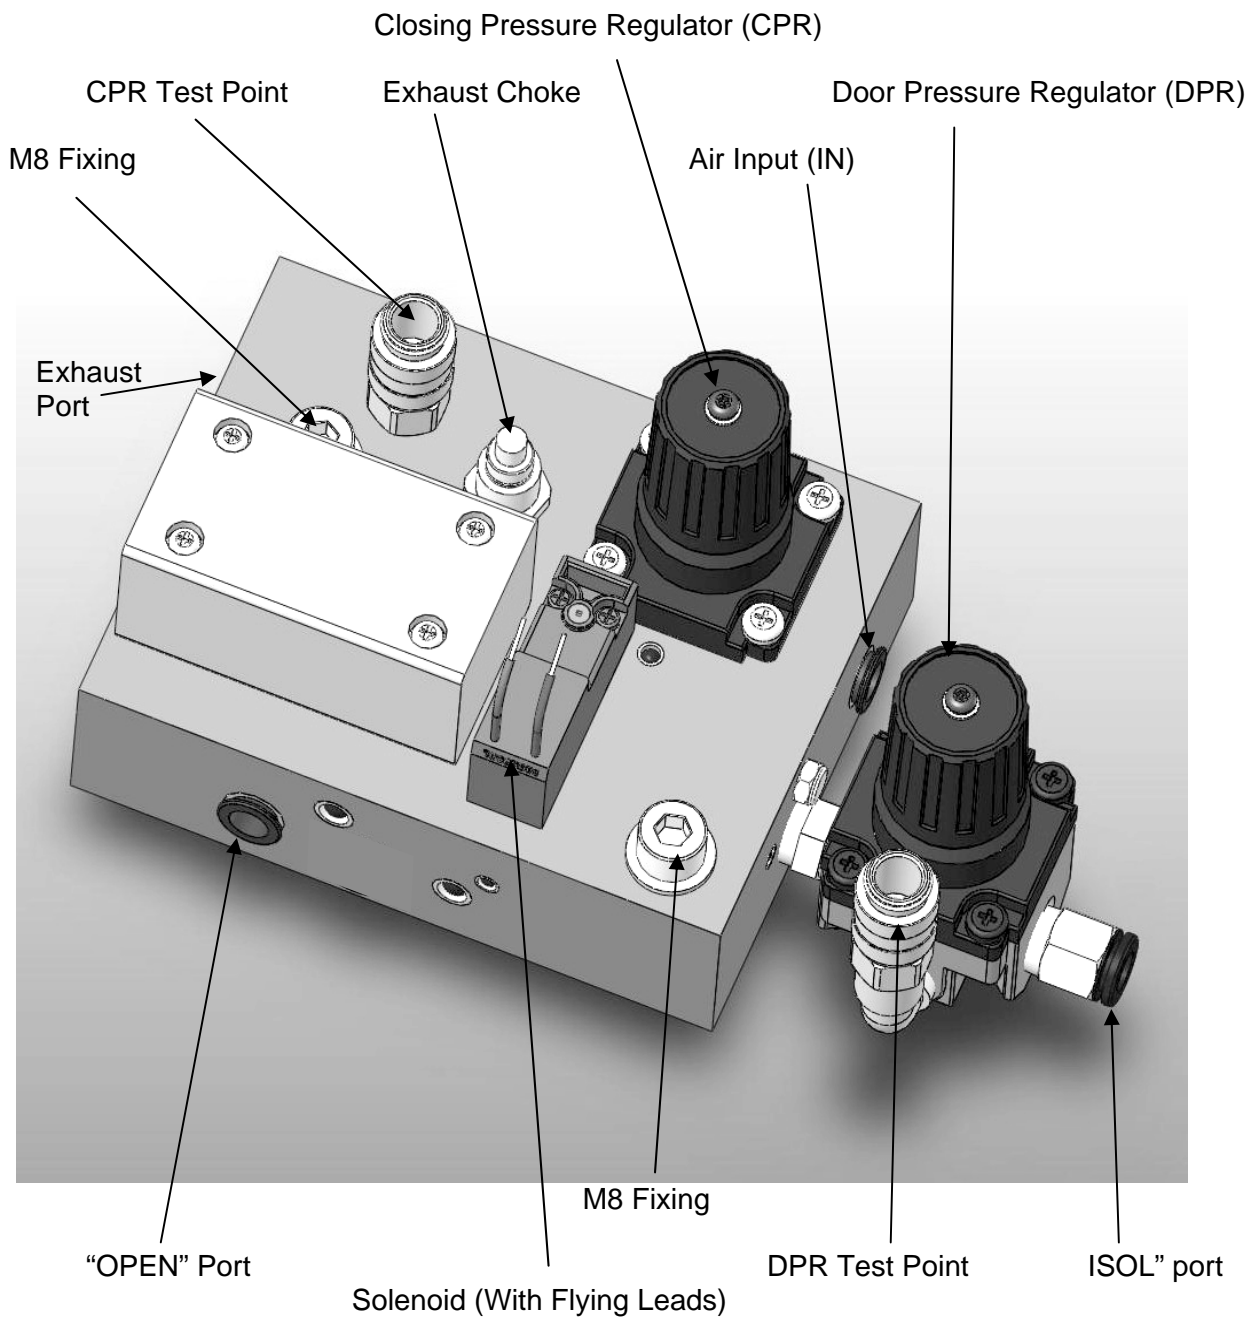
OJ 0138

Figure 9: Door Control Pneumatic Module

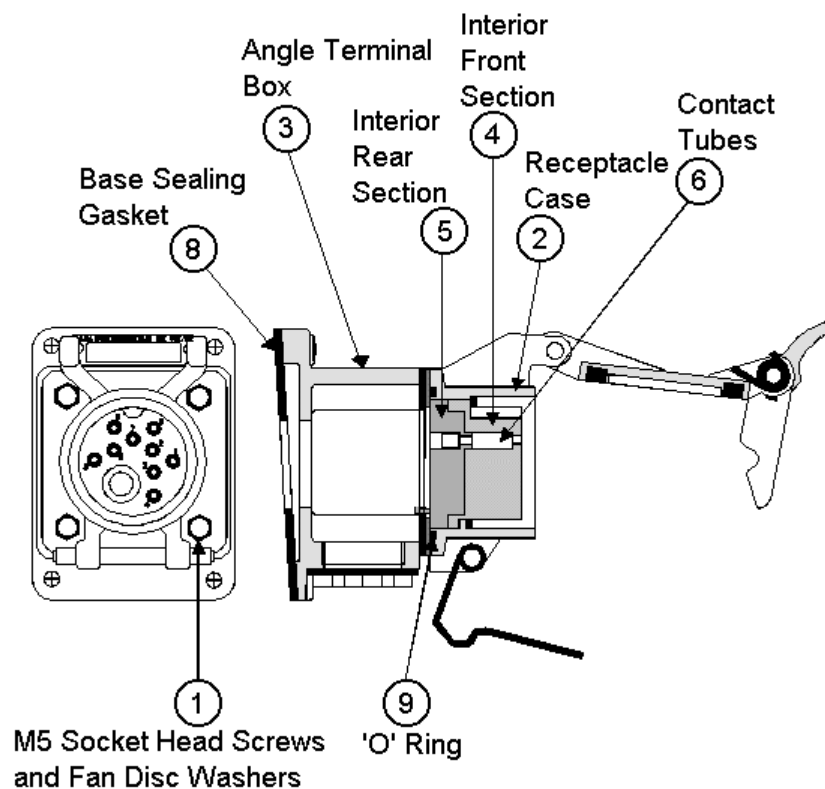
2. Remove the receptacle case, complete with hinged cover from the bracket on the vehicle.
3. Remove the 42mm locking nut securing the armoured conduit and receptacle base.
4. Discard the receptacle.
5. Check the jumper cable main receptacle mounting bracket for defects and security.
6. Obtain a new receptacle (see Materials item 1).

Figure 1: CDL Receptacle
