VEHICLE OVERHAUL INSTRUCTION

PB/VI2133

PORTERBROOK MARK 3 LOCO HAULED COACHING STOCK AND HST TRAILER VEHICLES

Issue: 5

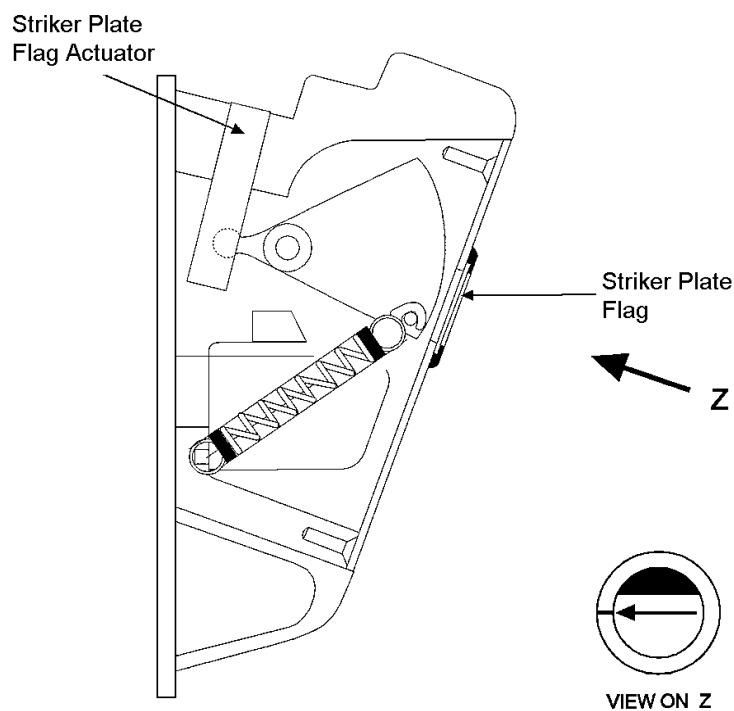
4. Examine the striker plate as follows:
 - 4.1 Check that there is no visible distortion, damage, wear or corrosion.
 - 4.2 With one finger, depress the striker plate flag actuator (see Figure 1), and check that the flag changes from yellow to black freely and without binding.
 - 4.3 Release the actuator and check that the spring returns the flag to yellow smoothly and quickly.
5. If required by the Engineer, renew the powder coating to an agreed specification.
6. Examine the cover plate, checking that the flag viewing window is fitted, with the blanking portion at the top.
7. Refit the cover plate and secure to the body with 4 cross head screws.
8. After Job No. OK 0115 has been carried out, check the alignment of the striker plate and locking bolt in accordance with Job No. OKA0116.

Figure 1: Cross Section of Striker Plate

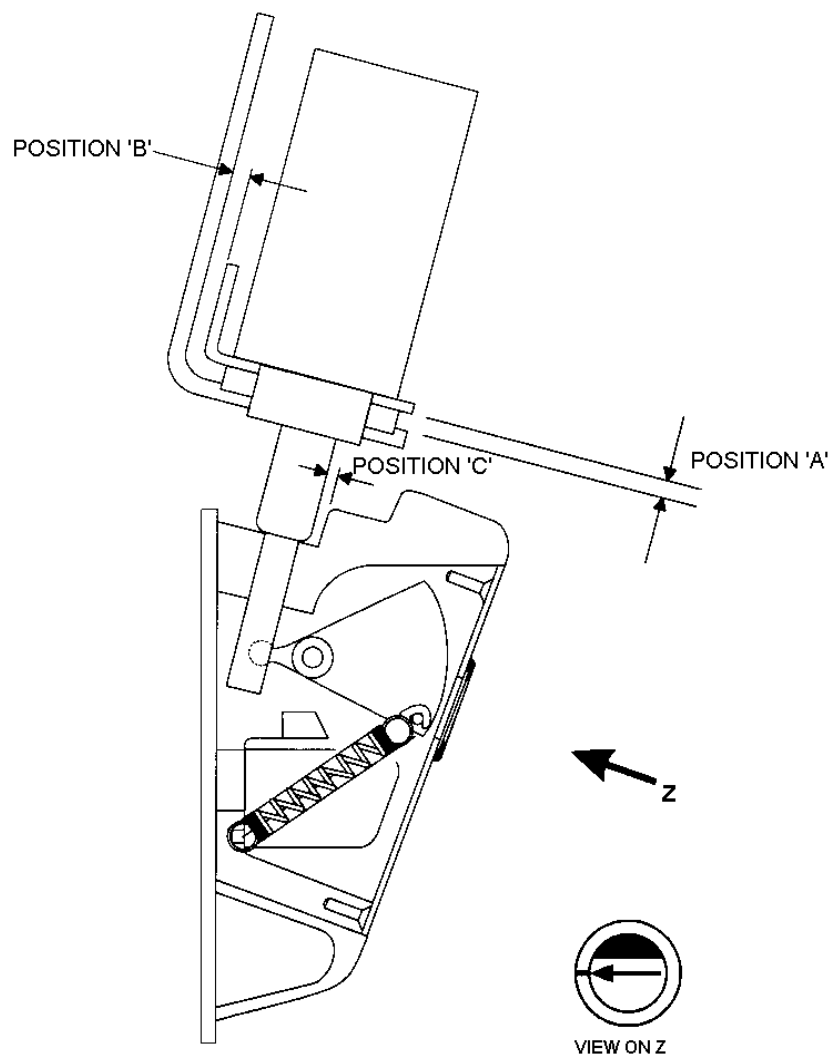
Figure 1: Door Bolt Adjustment

- 3.7 Repair defective bolt fastenings in accordance with Job No.OKA0131.

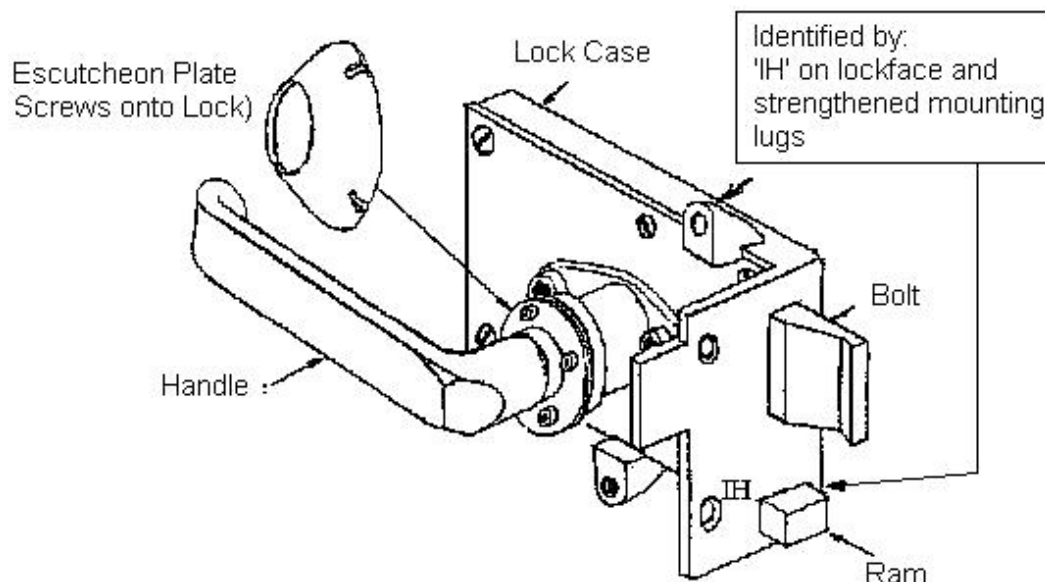
Figure 1: Mark 3 Coach Door Lock with Integral Handle

- B7. Any minor pitting may be corrected by the careful use of body filler (see Materials item 1) to provide a flat even surface to enable the escutcheon sealing washers to seal.
- B8. If the screw holes in the door edge are stripped or damaged or fixing screws are broken, the remains of screws to be drilled out and the tapping plate repaired in accordance with the specified document (see Reference Documents item 1 Procedure D Part 3).

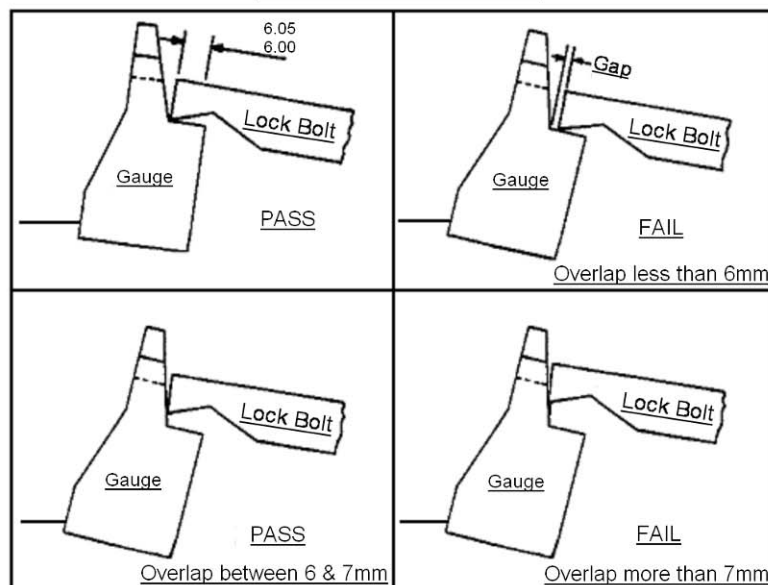
Place gauge over striking plate cam and bring lock bolt in propped position against striking plate cam.

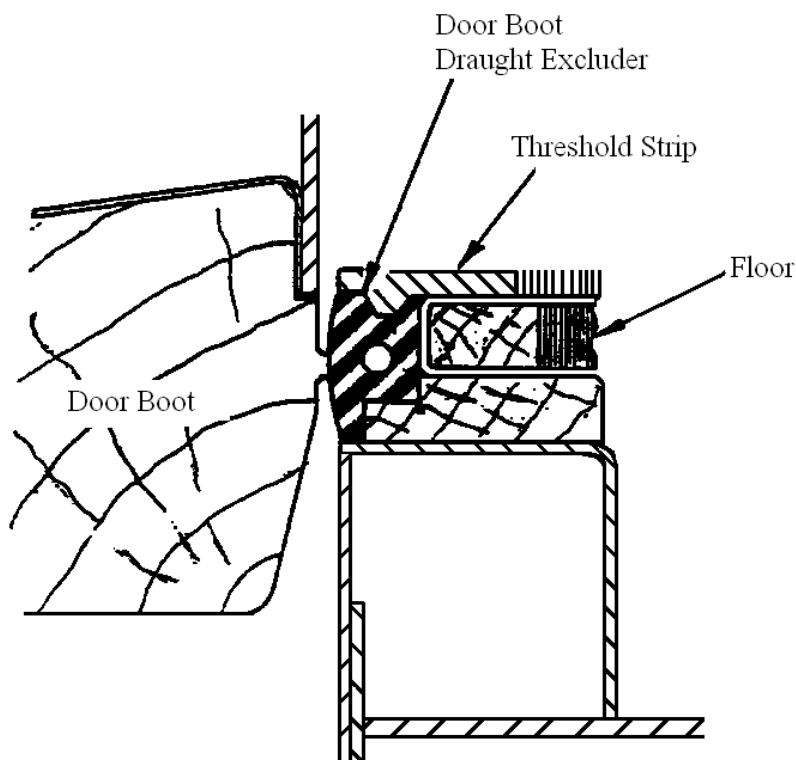
1. Remove the threshold strip securing the draught excluder.
2. Remove the existing draught excluder from the recess in the stepwell and discard.
3. Remove any pieces of rubber, dirt and old adhesive from the recess and the threshold strip.
4. Examine the threshold strip for damage.
5. Examine the recess for corrosion and rotting.
6. Cut the excluder (see Materials item 1) to length 950mm approx.

Figure 1: Section Through Stepwell

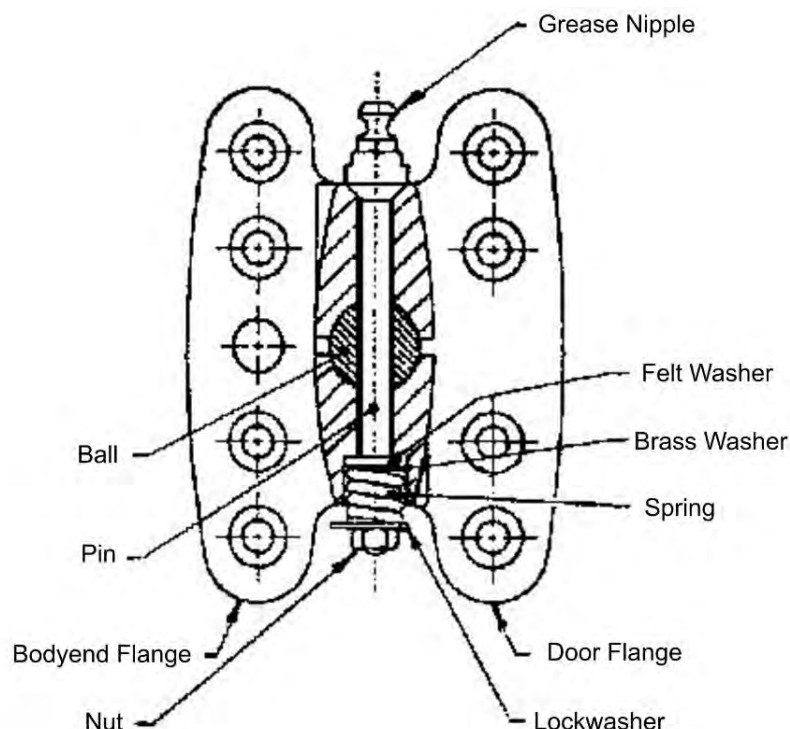
- 20.1 Place the door into position using the same lifting arrangement as for removing the door.
- 20.2 Grease the hinge cups, using a spatula and No. 3 Grease (see Materials item 2).
- 20.3 Insert the new balls in lower hinge cups, align the holes vertically. Insert new hinge pins.
- 20.4 Lower the door, checking that all hinges are correctly seated on their respective bearings. A gap of between 1 and 3mm must be noted between the two halves of the hinge. The gap on all hinges on a door must be approximately the same.
- 20.5 Fit the felt washer, plain washer, spring, tab washer and nut onto the lower end of each hinge pin (see Figure 1), tighten the nuts on the hinge pins until the tab washer just contacts the hinge body then turn back one flat, check that the door swings smoothly without binding or any free play in the hinges.

Figure 1: Arrangement of Hinge

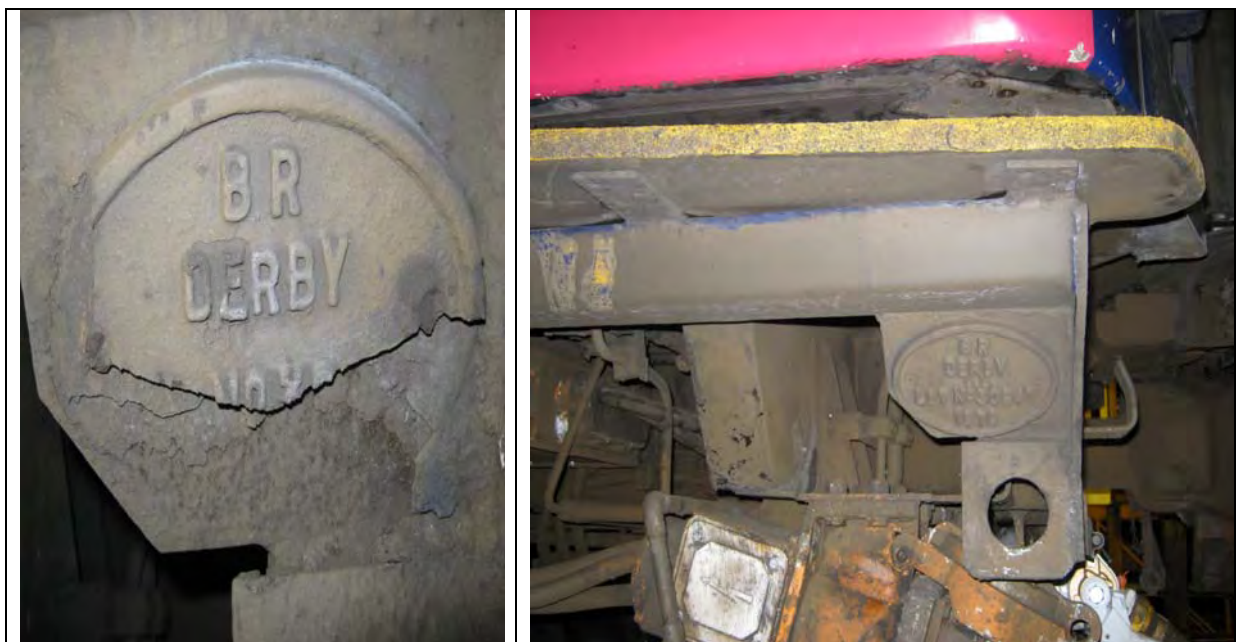
Figure 4: Example of Broken Builders Plate and Location

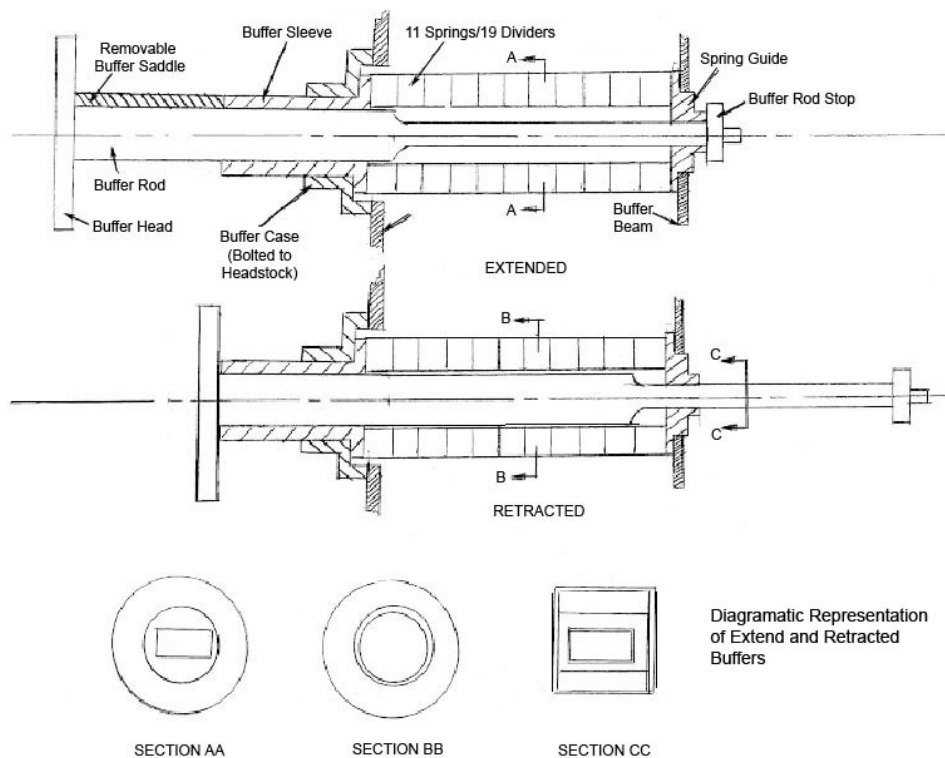
- 4.4 That the rod is perpendicular to the buffer head, +/- 1 degree.
5. Examine the buffer sleeve and check by gauging the following at each end:
 - 5.1 The inside contact diameter has not worn to more than 91.5mm at any point.
 - 5.2 The outside diameter has not worn to less than 126mm at any point.
6. Examine the buffer case and check by gauging the following:
 - 6.1 The smaller inside diameter has not worn to more than 130mm at any point.
 - 6.2 The larger inside diameter has not worn to more than 218mm at any point.

Figure 1: Sectional View of Buffer

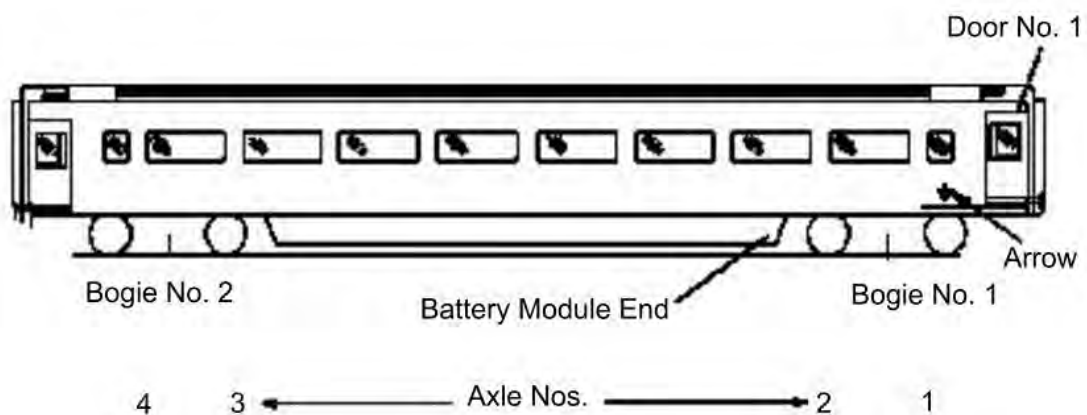
Figure 1: Identification of Axles

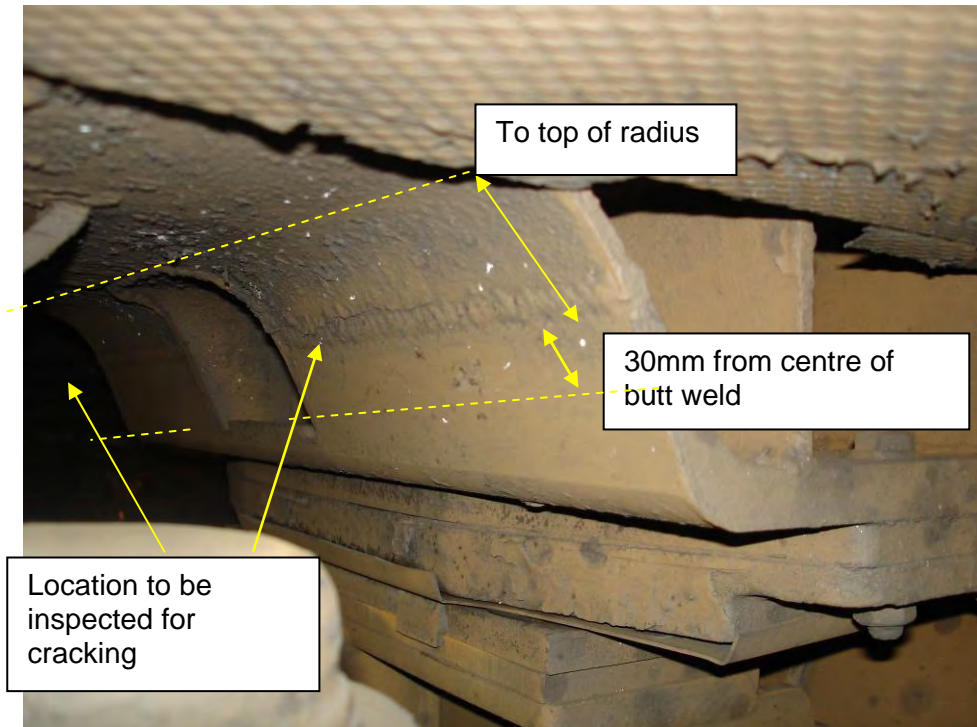
UU 3021

Figure 1: Weld Inspection Location at Bolster

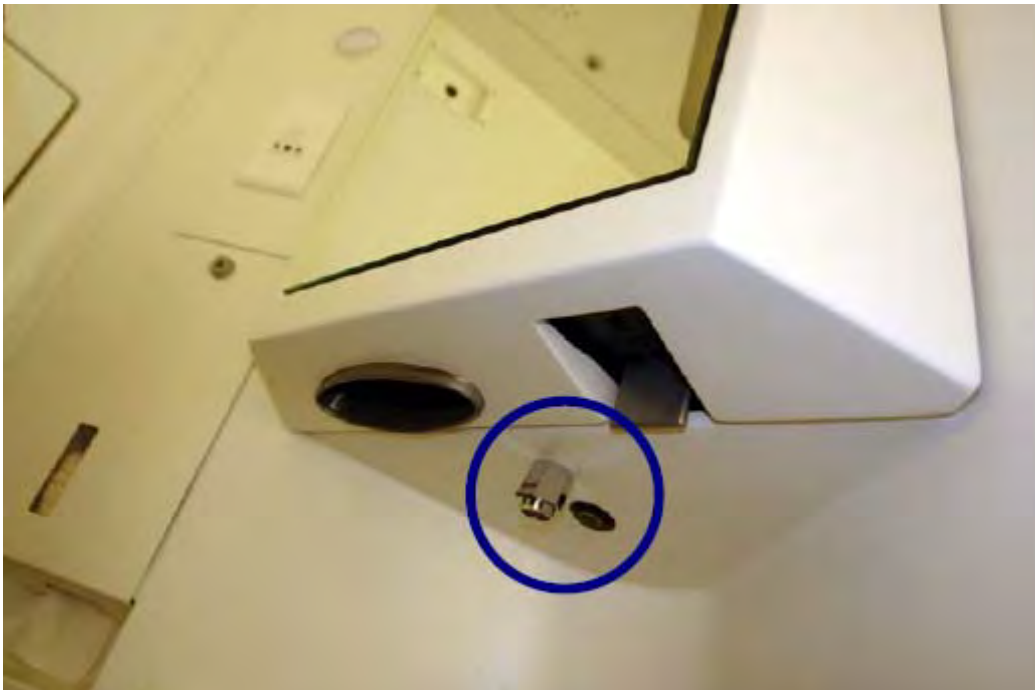
5. Examine the earth connection for defects and security.
6. Renew the water faucet cap as follows:
 - 6.1 Remove the water faucet cap (see Figure 3) and discard.

Figure 3: Water Faucet Cap Installation

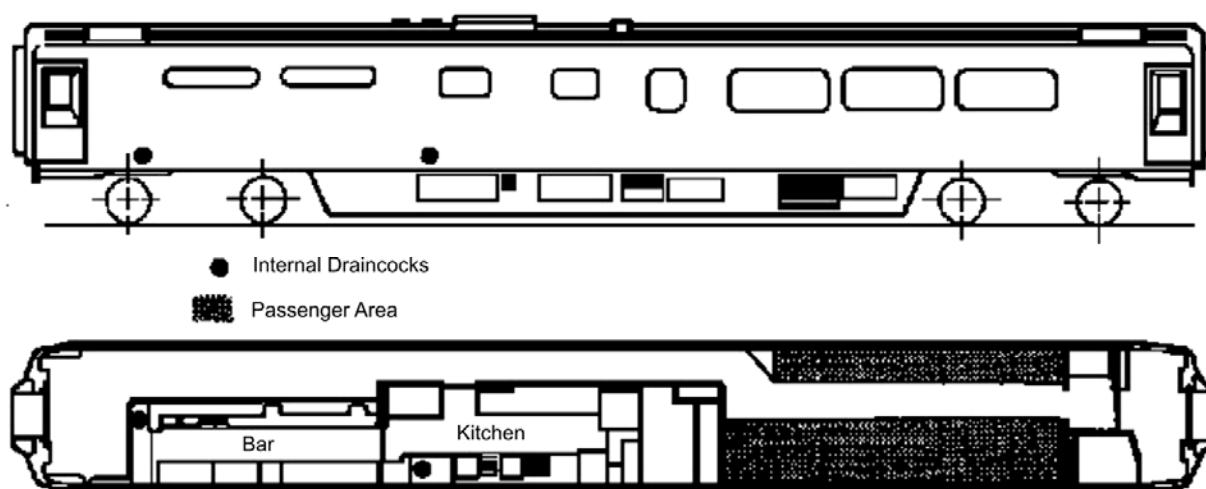
- Remove the litter bin stainless steel panel below the sink by removing 6 x M5 screws.
 - Open the roof water tank drain valve. Ensure that the Boiler water supply isolating valve is open (see Figure 2.4).
2. When water flows have stopped, close the cocks and refit or close the access panels.
 3. Place a notice "Water tanks and boiler drained" (see Materials item 1) in a prominent position in the kitchen.

Figure 2.1: Location of Catering Water Drain Cocks TRFB
